Depreciation Report

The Palisades Strata Corporation LMS 2472

1200/1288 Alberni Street, Vancouver, BC

Report No. 5130402.00

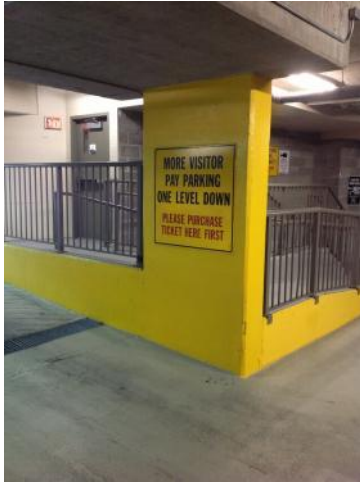
A01 – Painted walls in garage

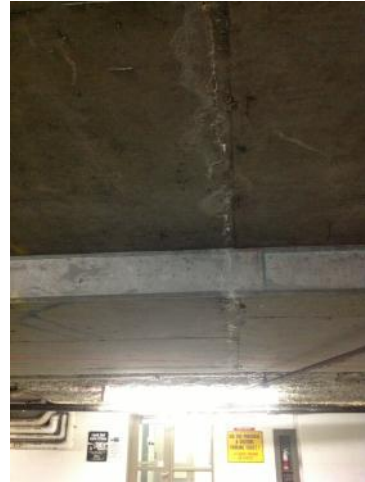
A02 – Water staining at garage ceiling

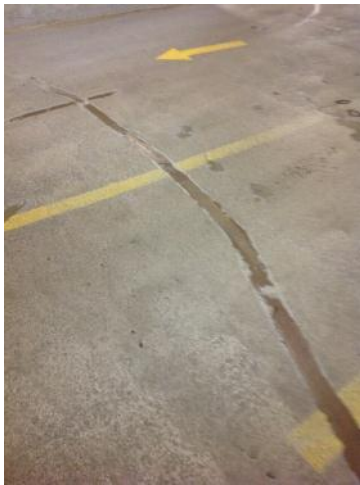
8	B1010 Suspended Slabs	Parkade Traffic Membrane	P1-P4 have a liquid urethane traffic membrane installed on the suspended slab. Some damage and past repairs were noted (Photo A03).	Fair	1996	Urethane traffic membrane typically has a life span of 10-15 years. Localized areas of damage can be fixed.	Replacement	3 - Renewal	17	15	5	4	Y	\$545,000
9	ENVELOPE													
10	B1010 Floor Construction	Balconies	Some units at 1200 Alberni are provided with balconies (not over living space). The balcony pedestrian wear assembly consists of tile on reinforced concrete; we assume some form of waterproofing membrane exists below the tiles. The undersides of the balconies are painted. The railings are mounted to the top of the balconies. Photo A04.	Good	1996	Replace pedestrian wear surface at balconies.	Replacement	3 - Renewal	17	20	7	1	N	\$30,000
11	B2010 Exterior Walls	Guardrails	All balconies and roof decks are fitted with top-mounted painted aluminum guardrails with glass infill panels.	Good	1996	Replace guardrails at the end of their service life. Regular maintenance should include replacing loose or corroded fasteners and damaged glass panels.	Replacement	3 - Renewal	17	35	18	1	Y	\$51,000

A03 – Repairs at traffic membrane in garage

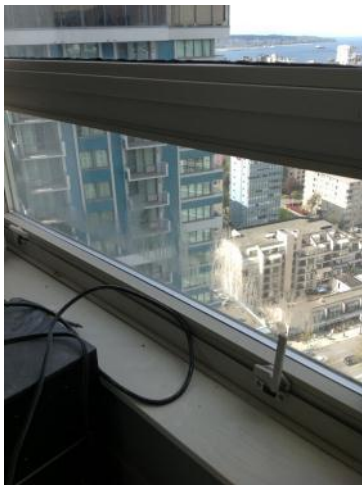
A09 – Clouding at IGU

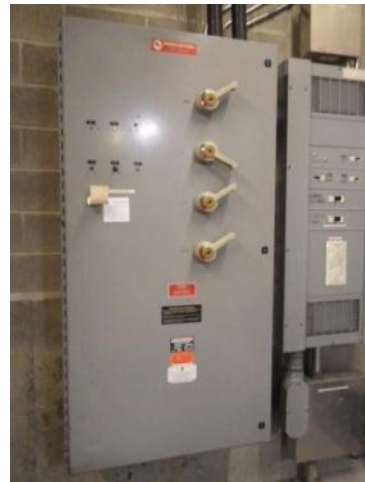
77	D5010 - Electrical Service and Distribution	Emergency distribution	Emergency building power loads are fed via two automatic transfer switches; 150A - fire pump, and 600A - lighting & elevators. Photo E03.	Good	1996	Replace transfer switches.	Renewal	4 – Discretionary	17	30	13	1	Y	\$18,000
78	D5010 - Electrical Service and Distribution	Electrical equipment	Electrical equipment is in good condition but requires regular maintenance.	Good	2010	With proper maintenance may survive the life of the building. The infrared scan, maintenance and cleaning is recommended every 5 years.	Repair Allowance	4 – Discretionary	3	5	2	1	N	\$12,000
79	D5010 - Electrical Service and Distribution	Residential metering centers	Metering center with combos of electrical meter and breaker dedicated for each unit.	Good	1996	Replace metering center (excluding electrical meters).	Renewal	4 – Discretionary	17	30	13	1	Y	\$70,000

E03 – Transfer switch

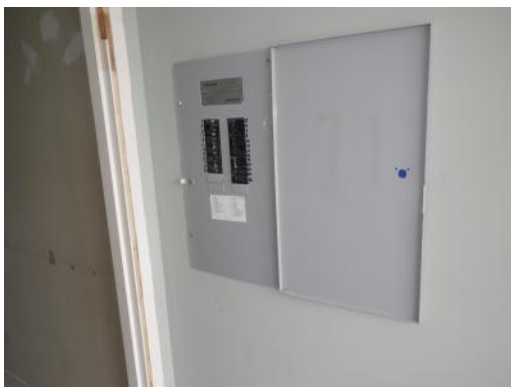
80	D5010 - Electrical Service and Distribution	Residential load centers	268 - 120/240V, 125A, and 4 - 120/240V, 200A load centers. Photo E04.	Good	1996	Replace load centers inside apartment units.	Renewal	4 – Discretionary	17	30	13	1	Y	\$158,000
81	D5020 - Lighting and Branch Wiring	Building indoor lighting	Majority of lighting system consists of CFL (compact fluorescent light), metal halide and T8 fluorescent tube lighting fixtures.	Good	1996	Replace lighting fixtures.	Replacement	4 – Discretionary	17	20	3	1	Y	\$58,000
82	D5030 - Communications and Security	Security system	Enter panels are located at main and garage entrances of the building. Support panels are located in the security room. 13 cameras are installed throughout the building. Photo E05.	Good	2010	Replace security equipment. Equipment has a typical lifespan of 15 years.	Replacement	4 – Discretionary	3	15	12	1	N	\$18,000
83	D5030 - Communications and Security	Telephone and TV cable	Located in the telephone room.	Good	1996	Maintenance and replacement of the equipment by service provider. No capital expenses anticipated.			17

E04 - Load centre

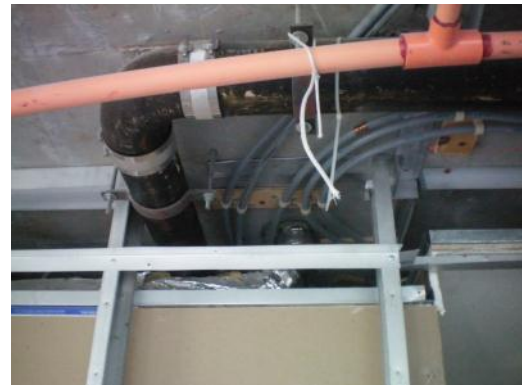
48	D202001 - Domestic Water Distribution: Pipes & Fittings	Water distribution piping within the suites	Piping within suites that runs to the fixtures from the sub-risers is polybutylene. The pipe is mostly 3/4" and is flexible, thus there are very few inline fittings. Refer to photo M03.	Good	1996	The polyB pipe also has a median life of 30 years. Replacement becomes imminent when the compression style fittings start having chronic failures.	Replacement	3 – Renewal	17	30	13	1	Y	\$1,500,000

M03 – Typical polybutylene piping within suites

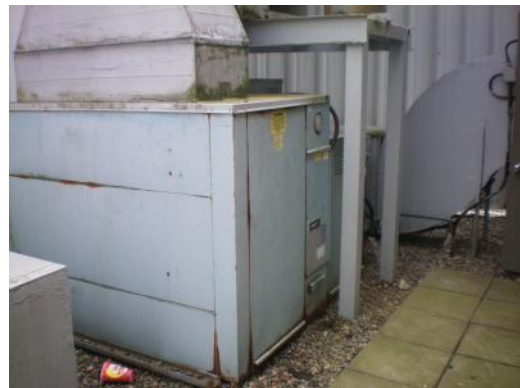
60	D304008 - Corridor Make-Up Air Units	West Tower Roof	Make up air for corridor pressurization is provided by an ICE gas fired roof top unit, with a 7.5 hp fan supplying 7,750 cfm and a 500 mbh input gas burner (photo M13). The unit just received a new heat exchanger (see photo M14) and appears to be in generally good condition.	Good	1996	Perform manufacturer's recommended maintenance (by maintenance contractor). The life of this unit has been extended by the replacement of the heat exchanger. The whole unit should be OK for at least another 16 years of service.	Replacement	3 – Renewal	17	30	16	1	Y	\$42,000
61	D304008 - Corridor Make-Up Air Units	East Tower Roof	Make up air for upper levels corridor pressurization is provided by an ICE gas fired roof top unit, with a 5 hp fan supplying 4,800 cfm and a 350 mbh input gas burner (photo M15 & 16) This unit is also getting a new burner installed shortly. Unit appears to be in fair to good condition.	Fair	1996	Perform manufacturer's recommended maintenance (by maintenance contractor). The life of this unit has been extended by the replacement of the heat exchanger. The whole unit should be OK for at least another 16 years of service.	Replacement	3 – Renewal	17	30	16	1	Y	\$35,000

M13 – Make up air unit on the West Tower

59	D304007 - Misc. Small Exhaust Fans	Throughout Building	Perform manufacturer's recommended maintenance (by maintenance contractor). Replace units as they fail.																														
60	D304008 - Corridor Make-Up Air Units	West Tower Roof	Perform manufacturer's recommended maintenance (by maintenance contractor). The life of this unit has been extended by the replacement of the heat exchanger. The whole unit should be OK for at least another 16 years of service.																	\$42,000													
61	D304008 - Corridor Make-Up Air Units	East Tower Roof	Perform manufacturer's recommended maintenance (by maintenance contractor). The life of this unit has been extended by the replacement of the heat exchanger. The whole unit should be OK for at least another 16 years of service.																	\$35,000													
62	D304008 - Corridor Make-Up Air Units	East Tower Level 2 ceiling	Perform manufacturer's recommended maintenance (by maintenance contractor). The steam coil will likely have some corrosion due to the moistue in the 100% outside air. Replace at end of life.

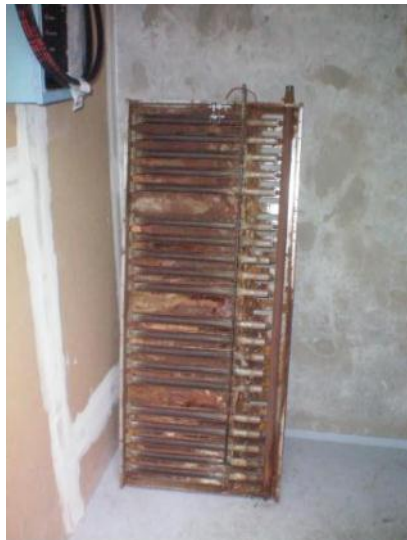
M14 – Burner removed from MAU on West Tower

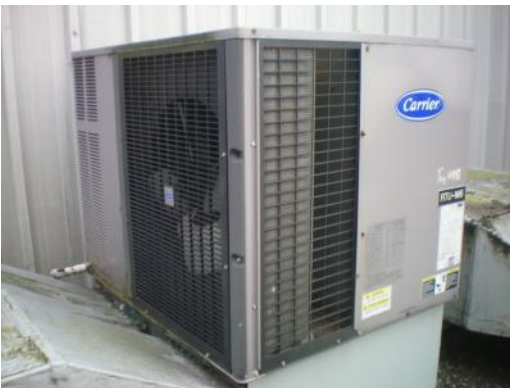
M18 – Cooling-only RTU for West Tower PH

63	D305003 - Roof-top penthouse cooling units DX	West Tower Roof	Perform manufacturer's recommended maintenance (by maintenance contractor). Replace at end of life.									\$63,000																					
64	D305003 - Roof-top penthouse cooling units DX	Eest Tower Roof	Perform manufacturer's recommended maintenance (by maintenance contractor). Replace at end of life.									\$63,000

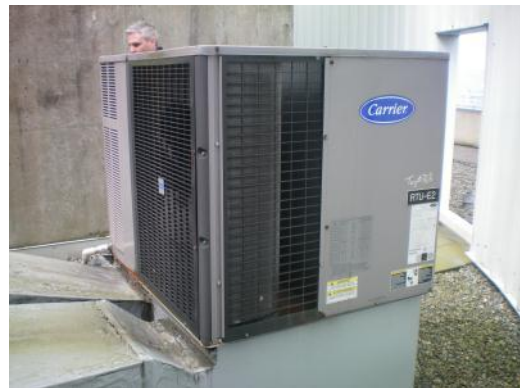
64	D305003 - Roof-top penthouse cooling units DX	Eest Tower Roof	There are 6 cooling-only 3 ton cap. roof-top units providiing cooling and ventilation to the penthouses. Most appear to be in good condition. Refer to photo M18.	Good	1996	Perform manufacturer's recommended maintenance (by maintenance contractor). Replace at end of life.	Replacement	3 – Renewal	17	25	8	1	Y	\$63,000
65	D40 - Fire Protection													
66	D401002 - Sprinkler Water Supply Equipment and Piping; Alarm Valves and Appurtenances	Water Entry Room / Major Valves	The buildings are fully sprinklered and supplied with both a wet and 4 separate dry-pipe sprinkler systems. The dry-pipe valves covers the parkade areas and the wet-pipe covers all other areas of the building. The components of the alarm valve assembly, such as the isolation valves, tamper switches, pressure and paddle type alarm switches appear to be in good condition (maintenance tags indicate that the components are properly maintained as well).	Good	1996	Perform the maintenance and testing of the system as required by code (by sprinkler maintenance and testing contractor). For funding purposes, an allowance has been recommended for overhaul of the 4 dry valve assemblies and the related active trim components in the system.	Repair Allowance	3 – Renewal	17	25	13	13	N	\$14,000

M19 – Cooling-only RTU for East Tower PH
