Maintenance Review & Roofing Condition Assessment

Pacifica

Strata Plan LMS 597
503 West 16th Avenue
Vancouver, BC

Sept 29, 2014

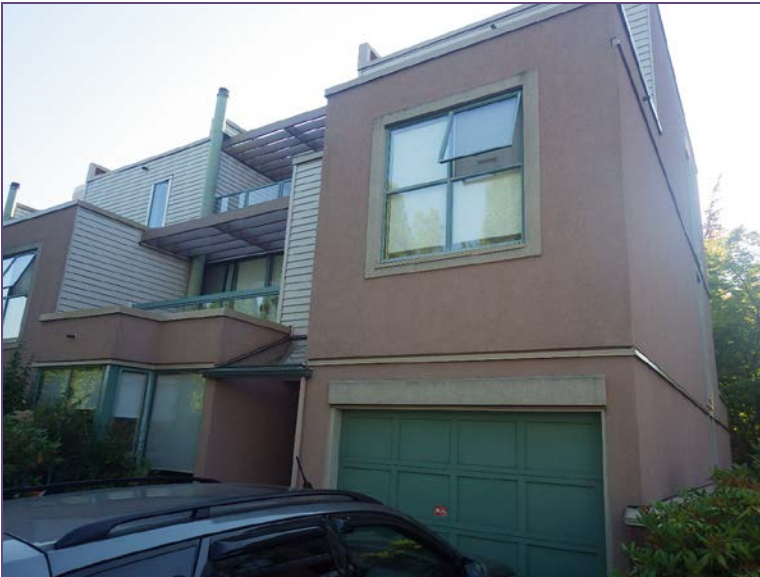
1. Promenade Mews: Stucco and vinyl is in good condition. Algae and carbon staining are starting to become visible.

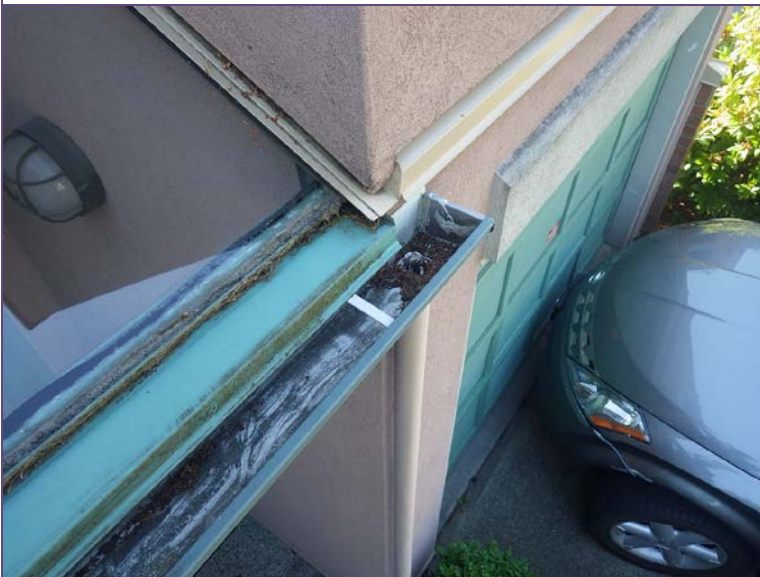
2. Promenade Mews: Gutters are relatively clean. Gutters should be cleared once per year minimum.

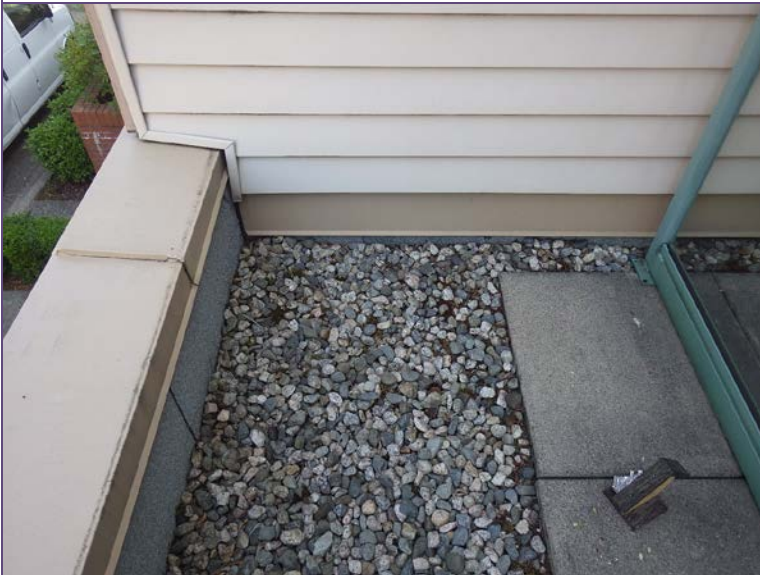
5. Promenade Mews: West elevation decks have gravel and paver covering. Flashing and siding are in good condition.

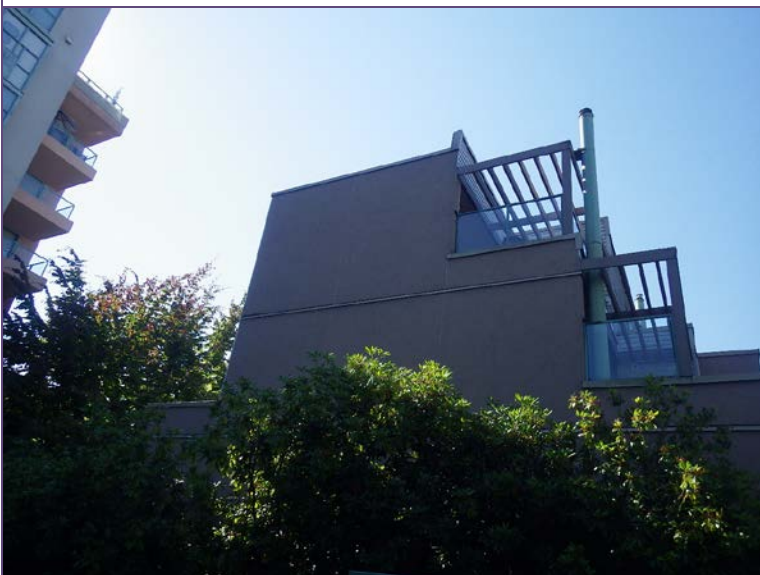
6. Promenade Mews: Wood trellises have been repaired and painted.

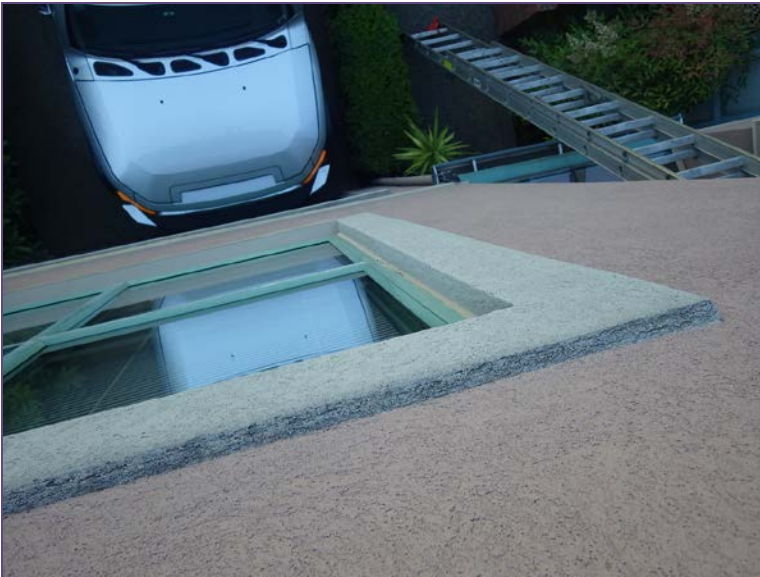
7. Promenade Mews:
Window sealants and
stucco trim are in good
condition.

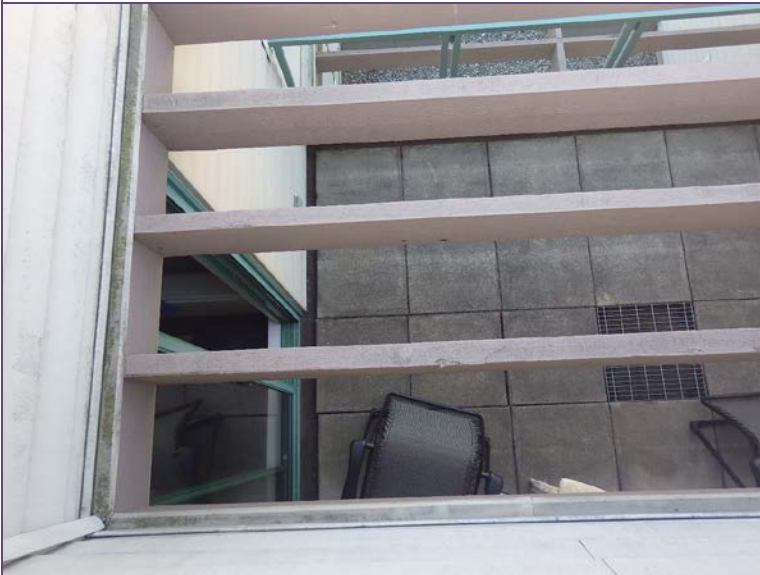
8. Promenade Mews: looking
down onto a typical
balcony deck. This
particular deck is clean
and trellis is in sound
condition.

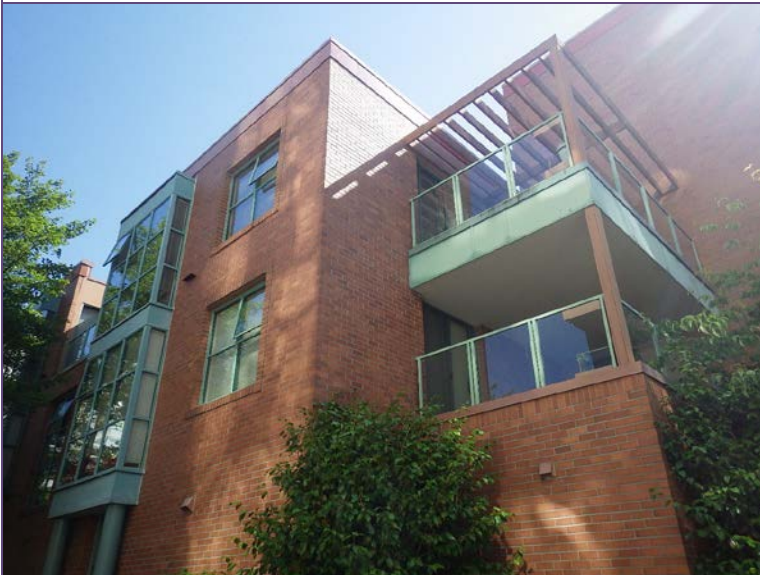
11. Bldg "D" (Cityhomes):
north elevation. Bricks are in good condition, trellise are in fair condition. Sealant renewal has been completed on this building.

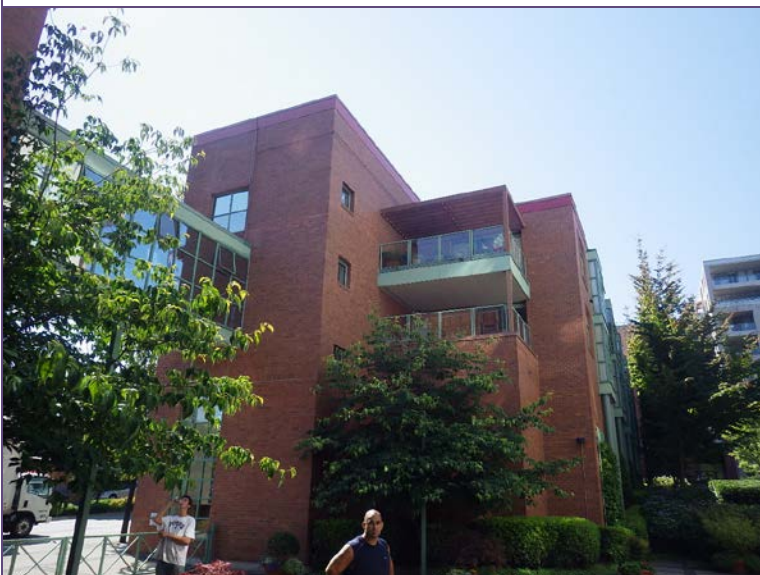
12. Bldg "E" (Cityhomes):
north elevation. Bricks are in good condition, trellises are in fair condition. Sealant renewal has been completed on this building as well.

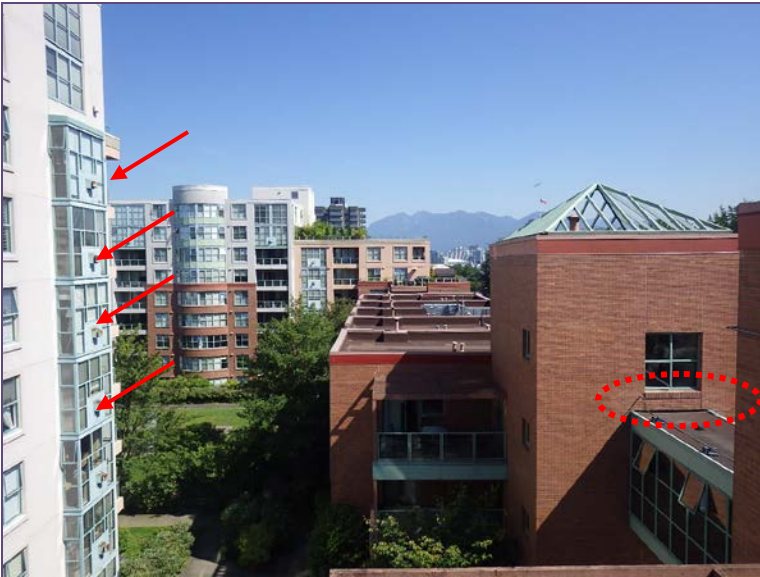
13. A view north from the main roof of Bldg. "E". Circle indicates an area that was repaired during maintenance work recently. Arrows indicate rusting fireplace exhausts.

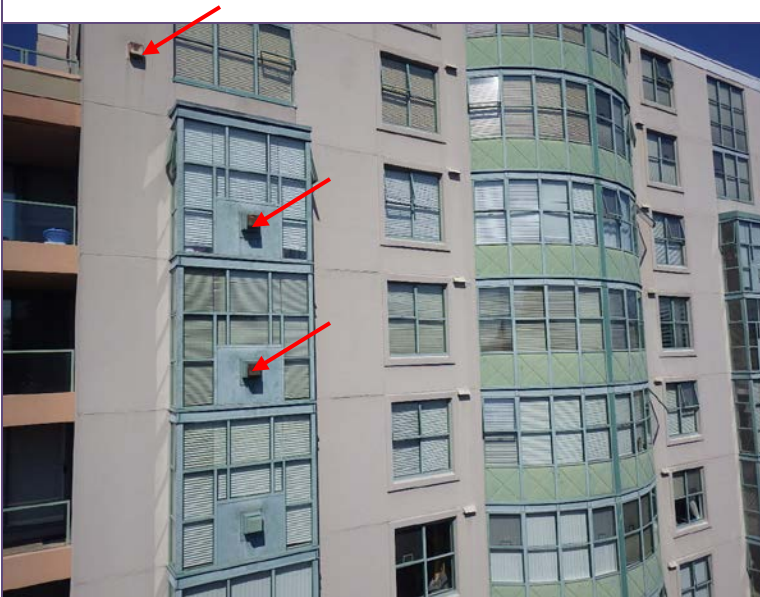
14. Bldg. "A" Maingate: East elevation showing EIFS cladding. EIFS appears to be in fair condition. Sealant joints have been replaced in areas. Fireplace exhaust housings are badly rusted in areas as indicated by arrows.

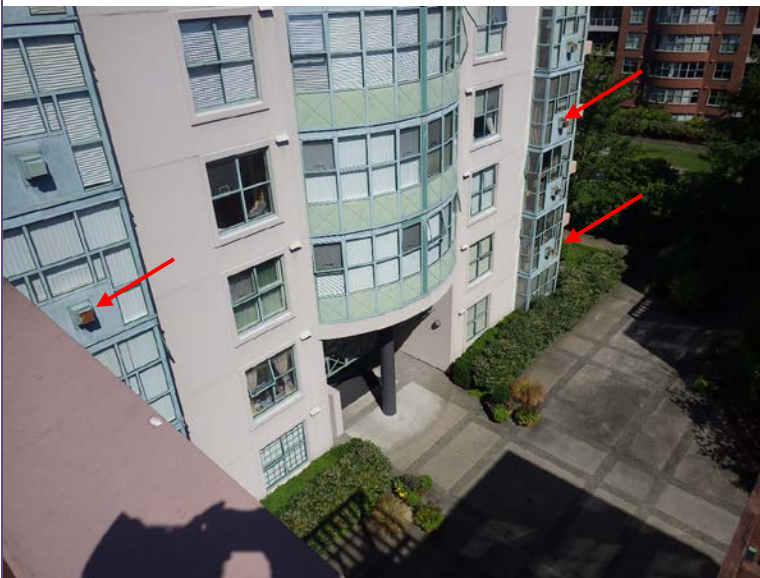
15. Front entrance to Bldg. "A" Maingate. Arrows indicate rusting fireplace exhaust housings. Fireplace exhaust housings are badly rusted in areas as indicated by arrows.

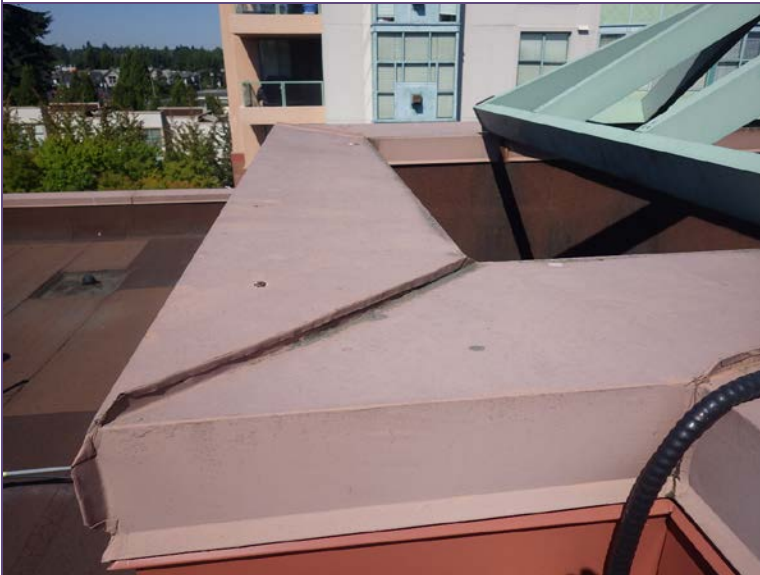
17. Bldg. "E" Cityhomes:
Curb and parapet flashing are in good condition.

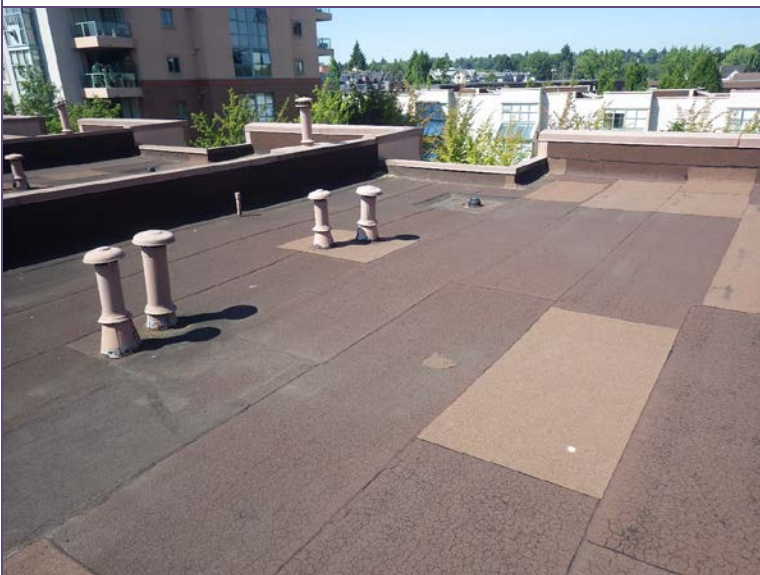
18. Bldg. "D": Roof surface is clean. There are many repair patches and cap sheet is heavily "alligatored" which indicates stress cracks in the top surface of the membrane caused by UV degradation.

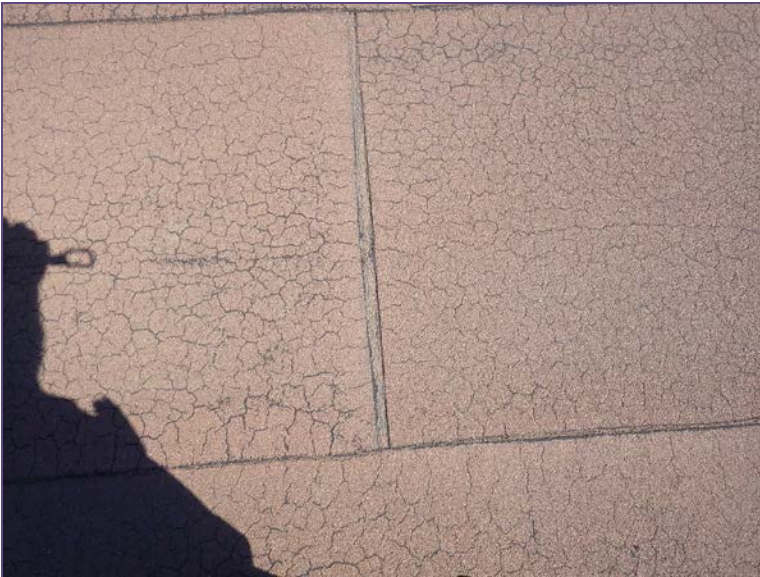
19. Cap sheet showing “alligatoring” as more and more bitumen is exposed the top surface dries out and shrinks causing small splits in the surface which exposes more bitumen. This is one of the typical failure mechanisms of granulated cap sheets.

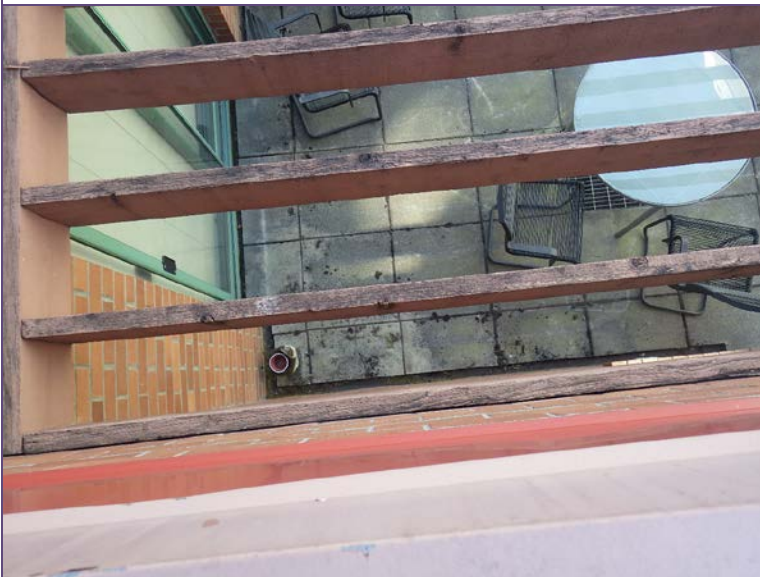
20. Bldg. “E” Cityhomes: A view down onto a typical balcony deck reveals heavy dirt and organic debris buildup on paver surface. Trellises at this building will require paint touchups and repair.

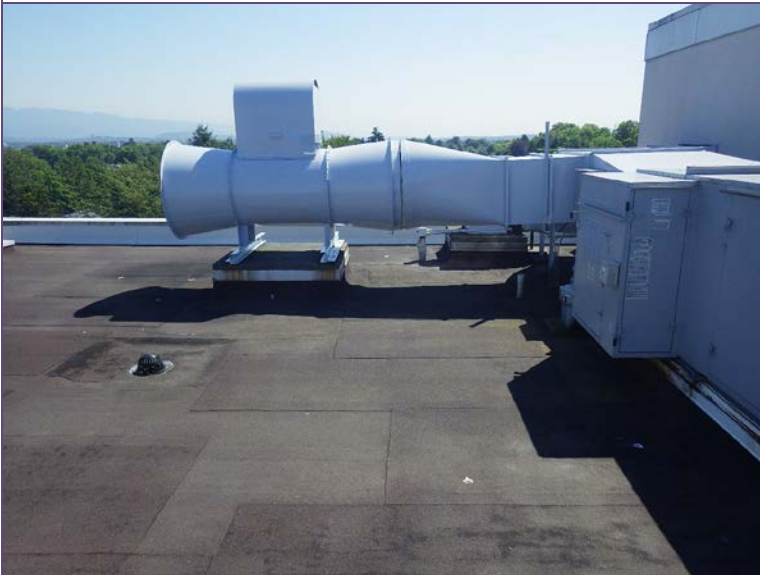
23. Bldg “C” Northgate: roof surface is clean. Severe granule loss, alligating, and general deterioration of the cap sheet was noted throughout this roof.

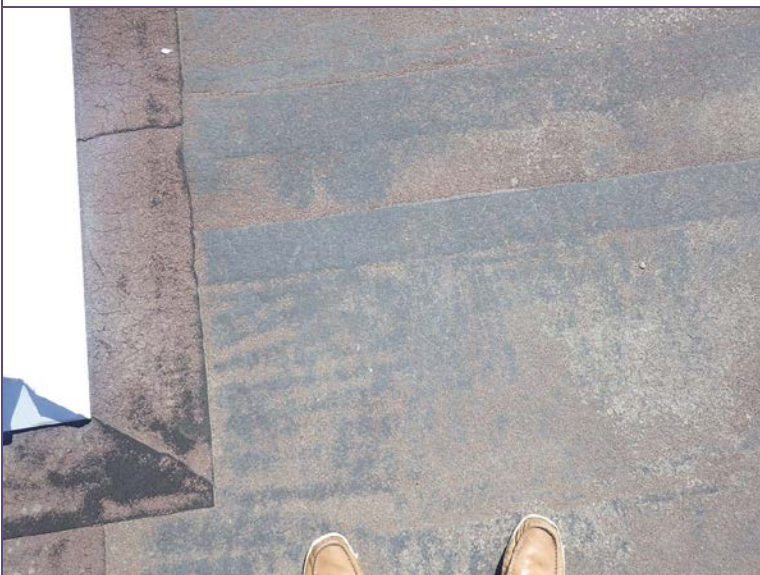
24. Bldg “C” Northgate: There are many bare spots.

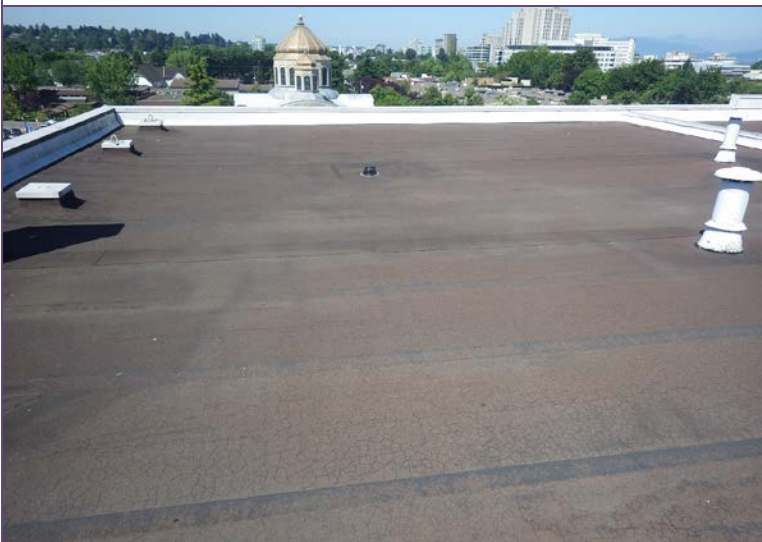
26. Bldg "C" Northgate: A view west over main roof. All roofs have good slope to drain. Roof anchor curbs and B- vents are in good condition.

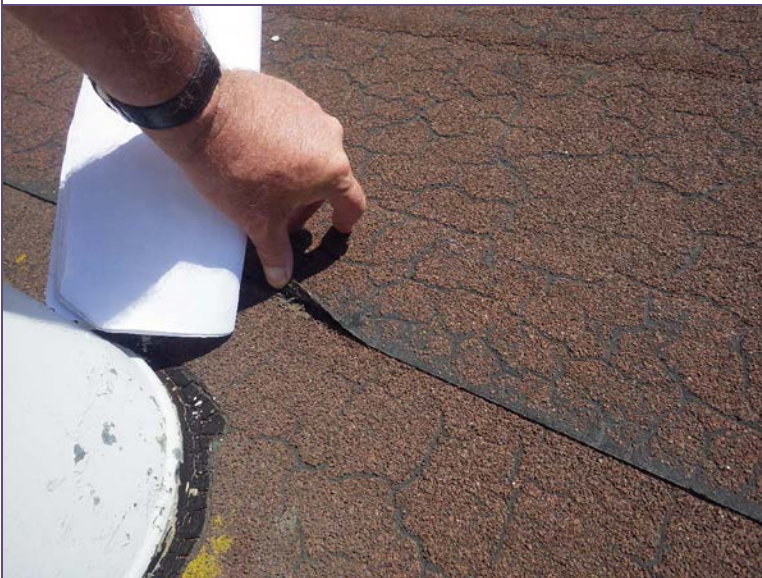
27. Bldg "C" Northgate: Some loose lap seams were noted. Bitumen loss from UV degradation was observed throughout this roof.

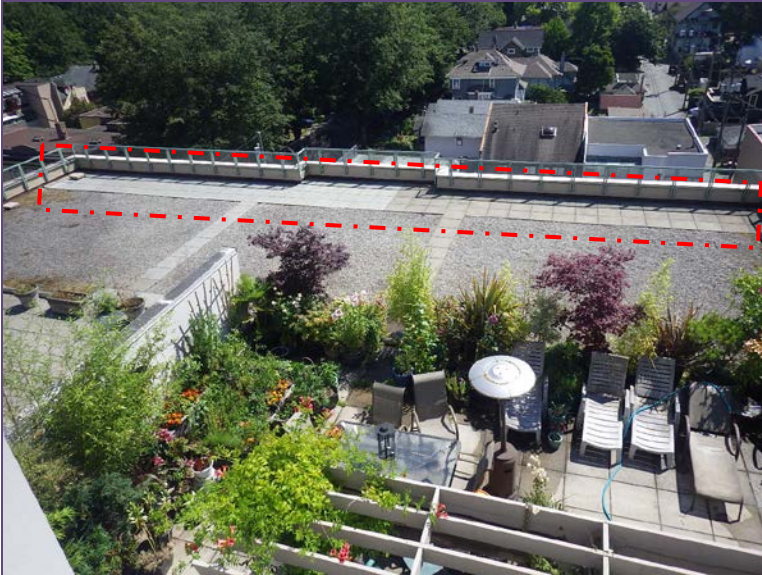
28. Overlooking 8th floor roof decks on Bldg “C”. Investigation of the area circled at unit 801C reveals a substantial roof repair which has converted the roof assembly into a “ballasted system”. More information is contained in “openings” photo compendium.

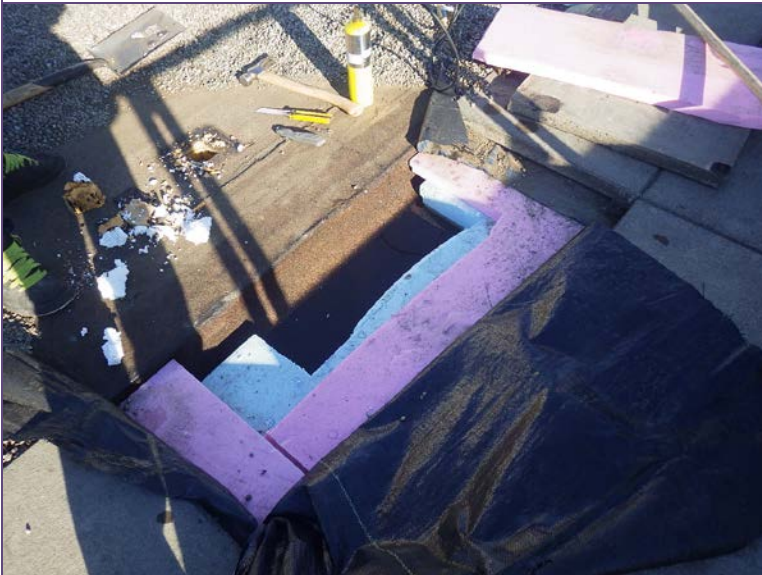
29. #801C showing new vs repaired roof area. Repair area has converted assembly to “ballasted” system wherein insulation is independent of the membrane and sits on top of waterproofing membrane.

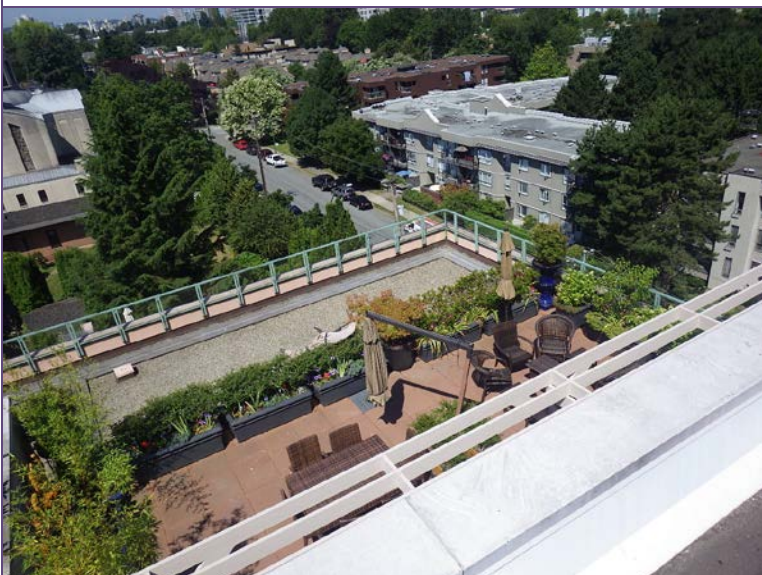
30. Bldg. “C” 8th floor roof decks. Trellis, railings pavers is in good condition. Roof decks are generally tidy and well kept. Membrane at the perimeter of these decks is in marginal condition.

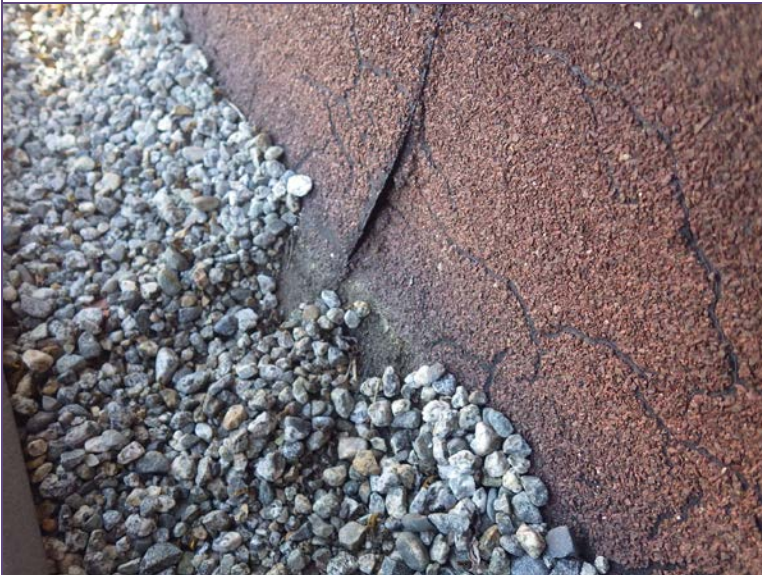
Another good feature in place at Pacifica is the use of pavers and gravel (whether by accident or design) loosely termed “protected” systems completely eliminates UV exposure which results in a longer life expectancy of bituminous membrane(s). It can be seen from observations and photographs taken from the site that exposed, granule covered cap sheet and stripping plies are failing even on roof decks with protected membrane systems. Conditions at units # 804B and # 803C demonstrate this condition[32, 33, 43].

32. #803C: loose stripping plies at parapet wall.

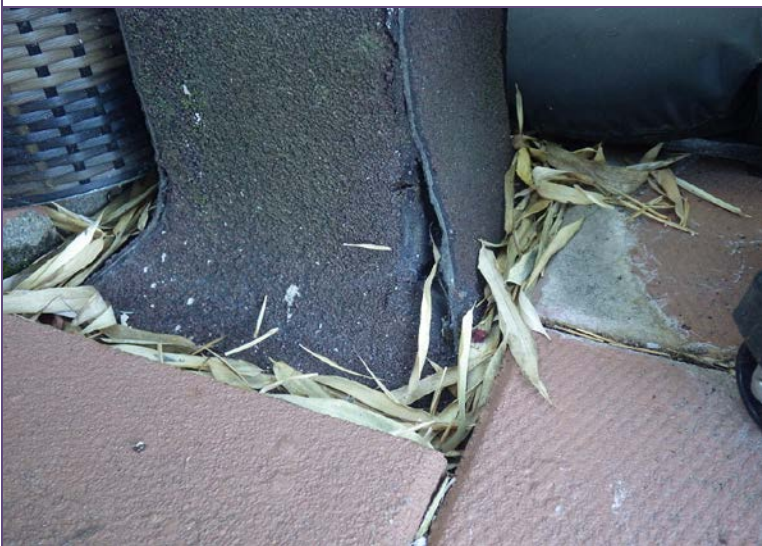
33. #803C loose stripping plies at trellis support.

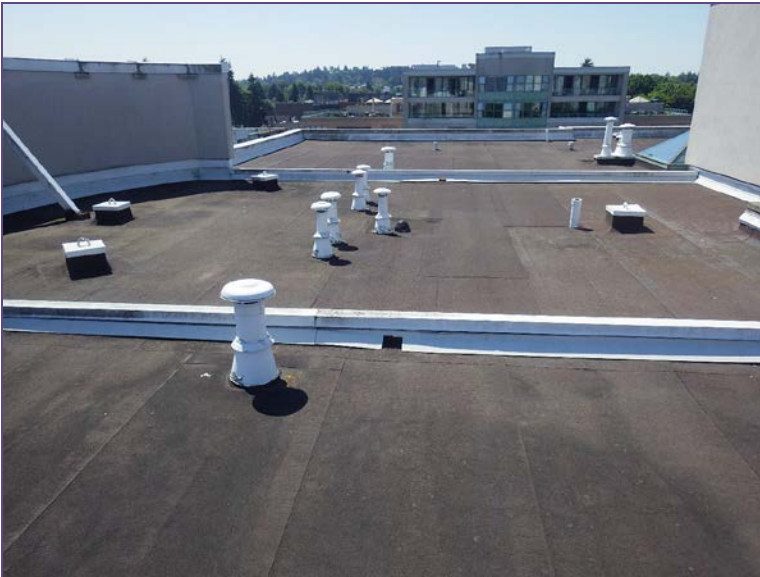
34. Bldg “A” Maingate: facing south across main roof. Membrane is in fair condition.

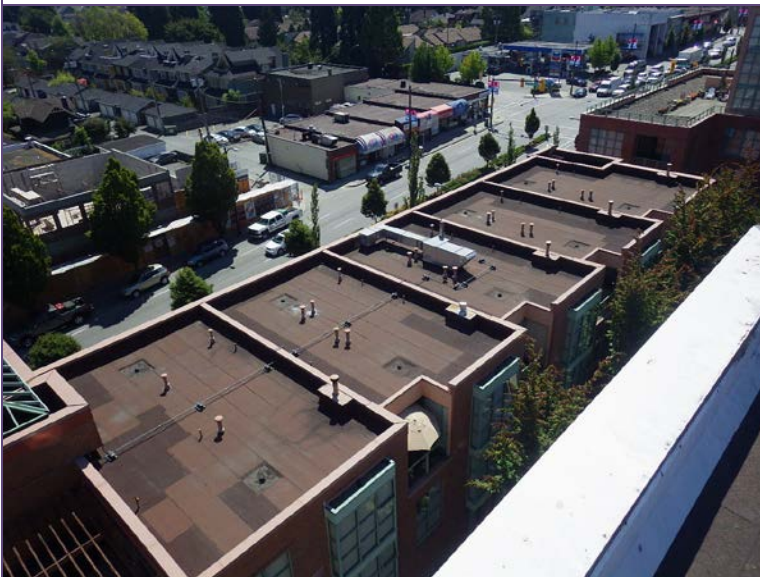
35. Bldg “F” Cityhomes: Looking down on main roof. Different shades of cap sheet indicate areas where the roof had additional plies of membrane installed under a warranty claim.

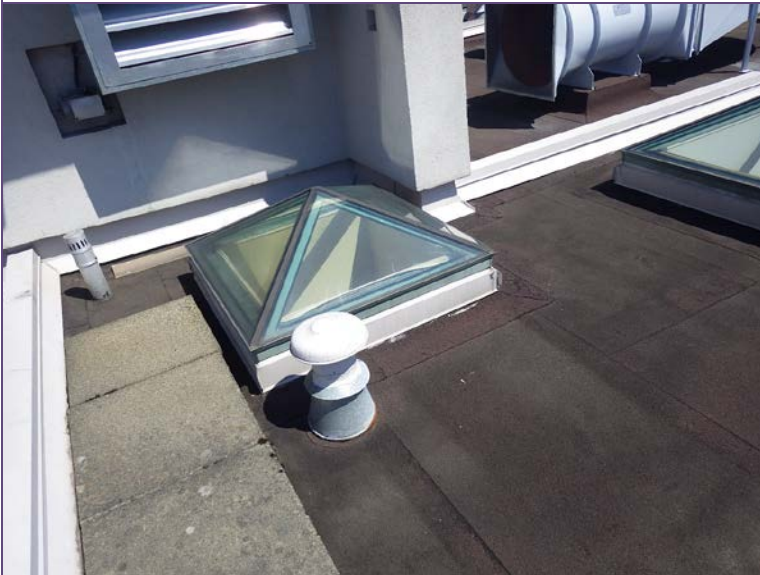
38. Bldg "B" Southgate: Skylights glazing and flashing are in fair condition.

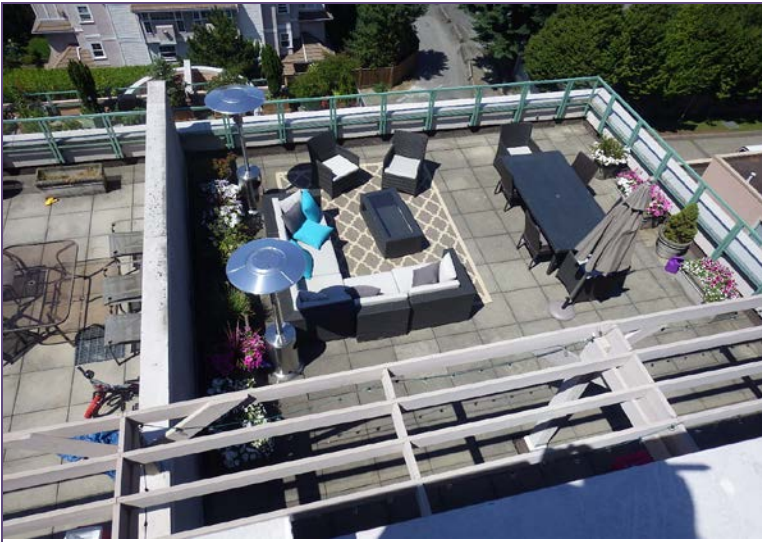
40. Bldg "B" 801B: roof decks are in a clean and tidy condition. Trellis, railings and pavers are in good condition. Roof leaks have been reported coming from this deck. Repairs have been made.

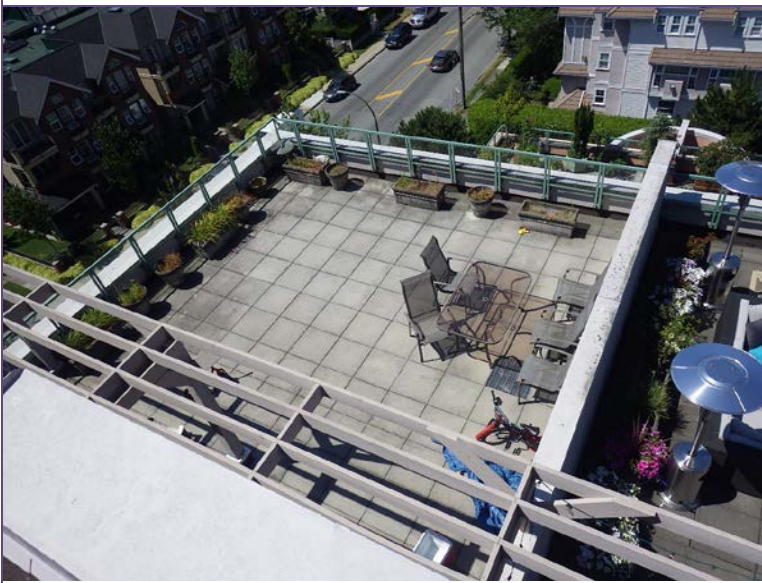
Membrane cut tests were taken from both of these units with water saturation found in all layers of the assembly at unit #804B. Leaks were reported below units #801B and #804B in January of this year and cut tests confirm waterproofing and insulation has been compromised.

41. #804B: Roof deck is clean and tidy. Waterproofing has failed and cut tests reveal complete saturation. Previous leaks have been reported at this deck.

Recommendation	Category/schedule	Opinion of probable cost
1. Replace membrane and insulation at units #804B and #801B.	Priority replacement within one year. (2015)	\$95,000 + GST
2. Replace membrane and insulation on main roofs of Bldgs. "D" & "E". (3060 excluded) Replace membrane and install insulation on all lower roofs and decks.	Priority replacement within two years. (2016)	\$147,500 + GST
3. Replace membrane at main roof of Bldg "C".	Depreciation replacement (2018)	\$270,000 + GST

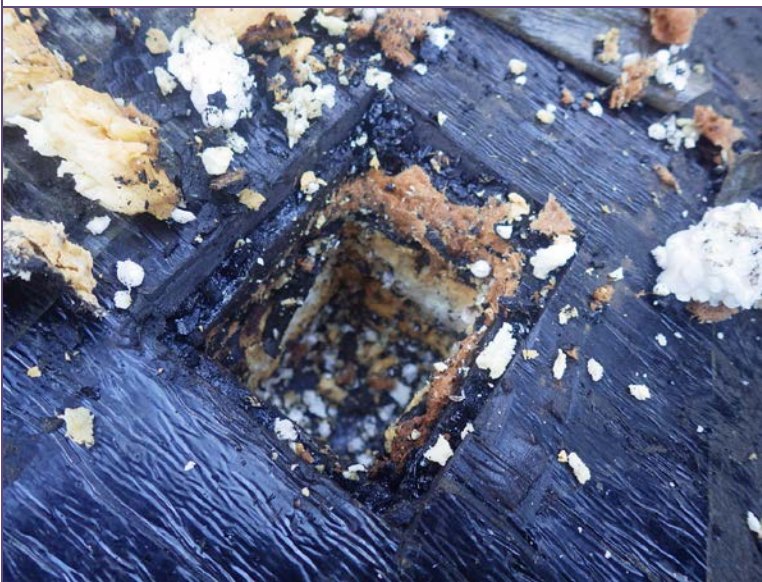
42. #804B Membrane cut test. All layers of insulation are saturated.

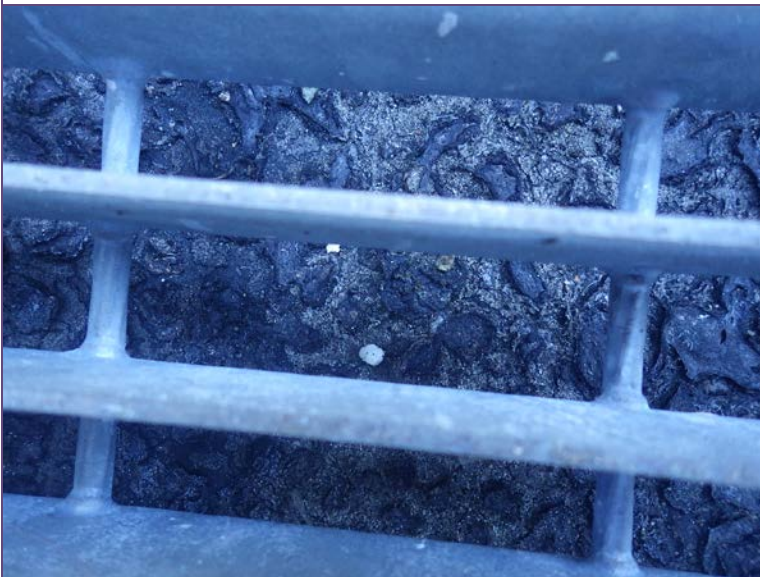
44. #804 B membrane inside the drain grate appears to be damaged.

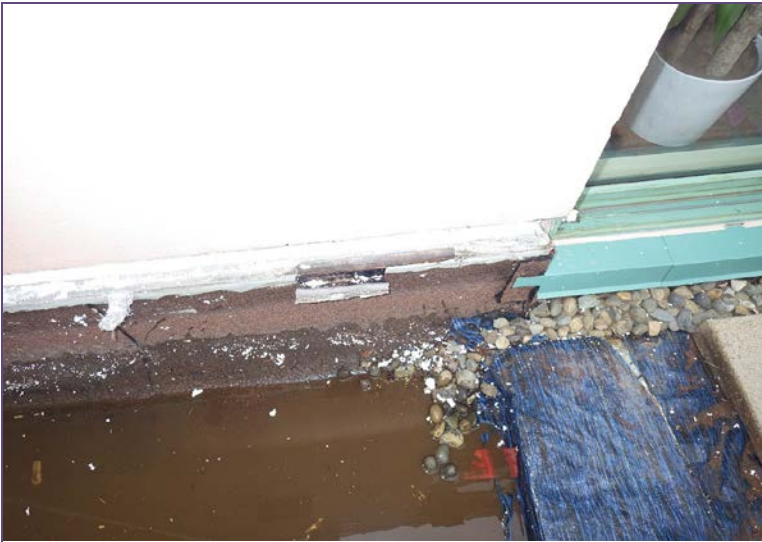
46. #609C A typical wall base detail at all Pacifica roof decks has membrane turned up onto EIFS cladding without a separation flashing. If sealant or flashing fail water can enter behind the membrane and into the building.

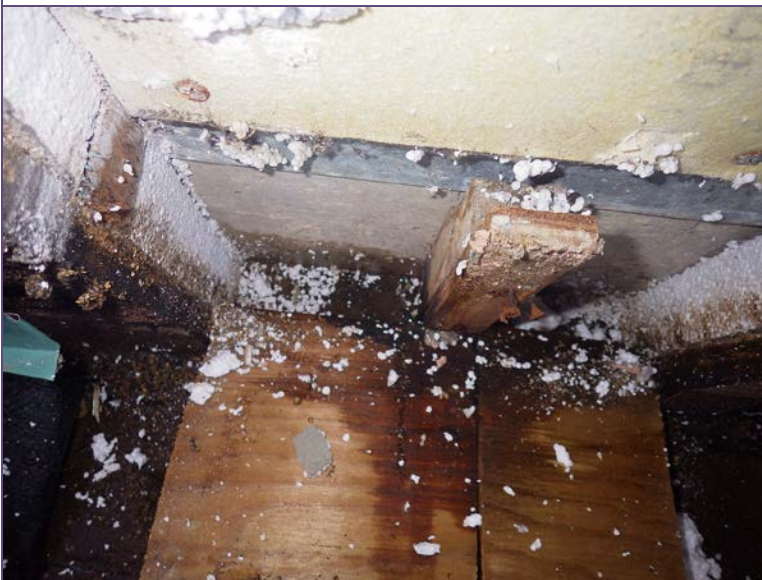
47. Another view with wall base membrane removed.

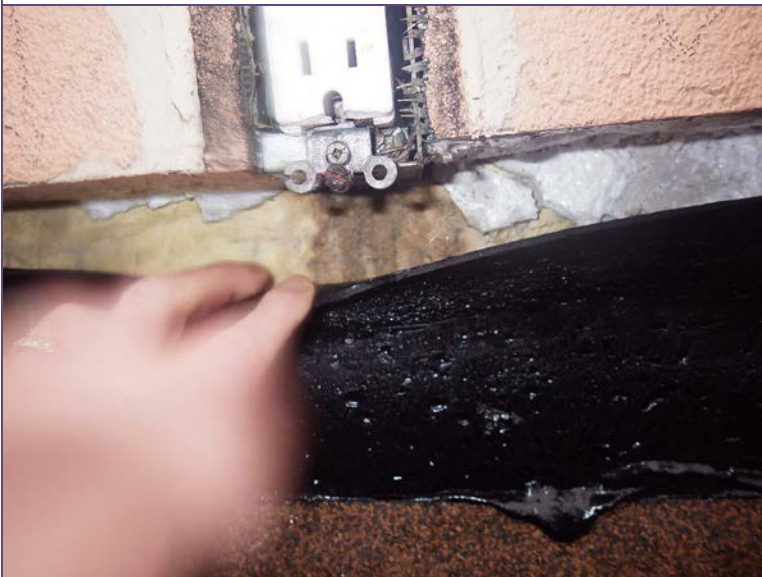
Recent roof membrane replacement and sealant renewal at #609C revealed that there is no continuous waterproofing layer behind the EIFS and it is spot adhered with adhesive directly to gypsum sheathing[50]. The EIFS is a face sealed system with no drainage provisions behind the cladding. Detailing defects at wall bases also revealed that membrane is upturned onto the exterior face of the cladding [47]and there is no through wall or cutoff flashing installed to direct water to the exterior if it were to enter the cladding at a higher point. The penetrations, window openings and architectural features are almost entirely dependent on sealant to keep rain out[50]. Although a comprehensive sealant renewal and painting program was initiated by the Strata Corporation it is evident that moisture ingress is still occurring. Trapped water was discovered in the sealant joints and at the wall base during the repair. The repair did involve modification of the wall base detail. A close-up of a painted over EIFS finish is included in the photo compendium[49]. As discussed previously extraordinary rain penetration on east elevations of buildings is a well documented on the west coast of BC. The depreciation report recommends EIFS removal and replacement starting in 2018, and it goes on to state replacement should be based upon results of a condition assessment. CSA recommends replacement of the EIFS cladding on the east elevation of

50. A view behind the membrane at #609C. EIFS is spot adhered to the gypsum sheathing and without a moisture barrier. Moisture ingress at penetrations is represented by stains on the gypsum face.

Recommendation	Category/Schedule	Opinion of Probable Cost
6. Replace EIFS cladding, moisture barrier, windows and doors at east elevation of building “C” between 6 th and 8 th floor. Replacement should coincide with 8 th floor roof deck and main roof membrane replacement. 3500 sq ft includes glazing area.	Depreciation replacement 2018	\$227,500
7. Commission EIFS Condition Assessment	2016	
8. Replace membrane on roof decks of 801C & 802C to coincide with main roof replacement Bldg “C” and EIFS replacement. 4400 sq. ft.	Targeted replacement and bundling of wall cladding and roof replacement in the same area. 2018	\$ 242,500
9. Replace membrane and insulation on main roofs of Bldgs. “F & G Cityhomes. Include membrane under aluminum canopies.	Depreciation replacement. (2019)	\$260,000

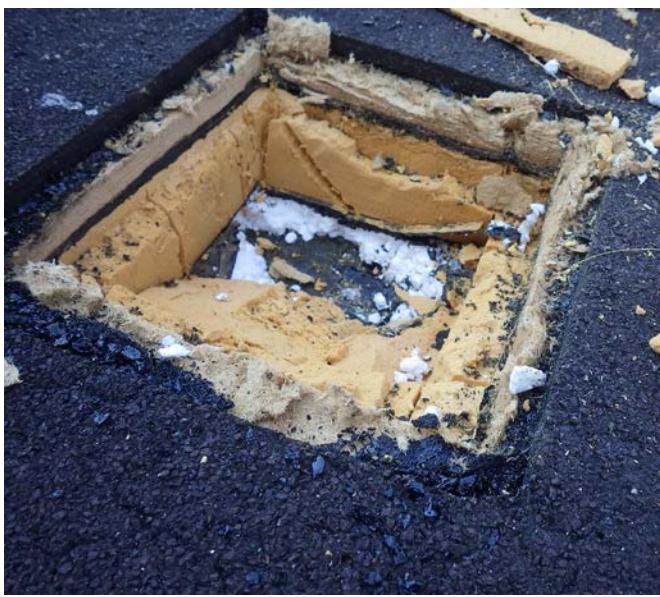
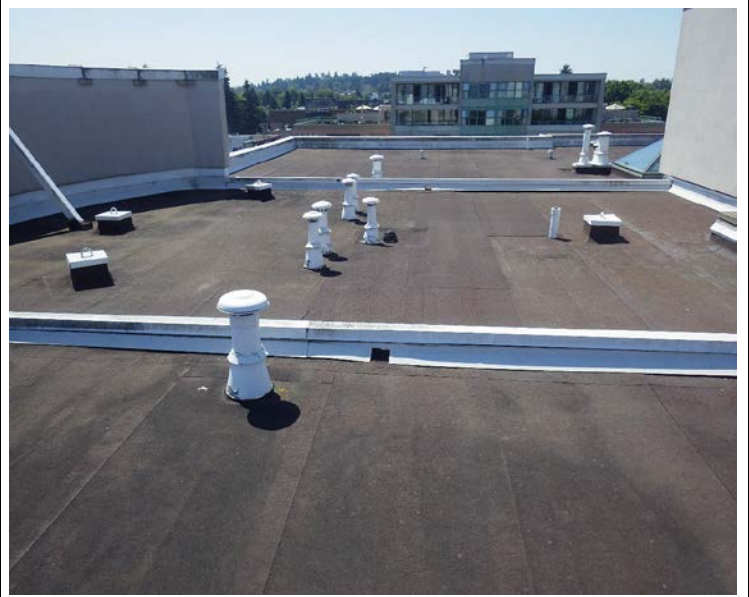
OPENING #01

Opening Type:	Membrane cut test
Date of Opening:	July 15, 2014
Location:	Bldg "A" Maingate main roof
Observations:	Alligatoring, bare spots, and many patches on the roof surface.

Substrate Condition: Good No water present in the system

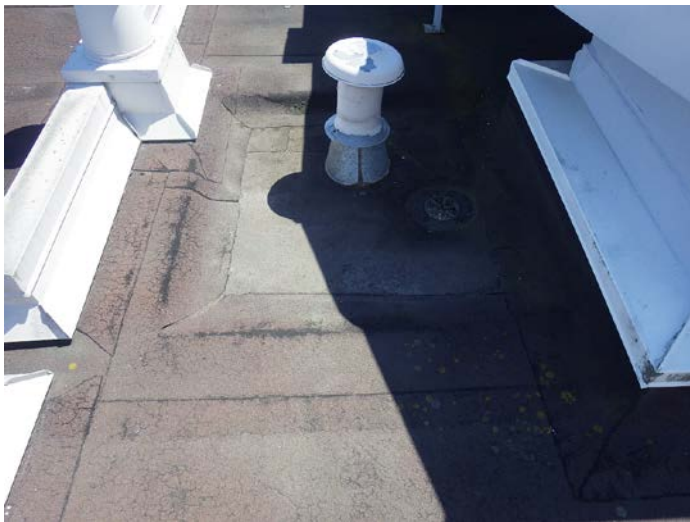
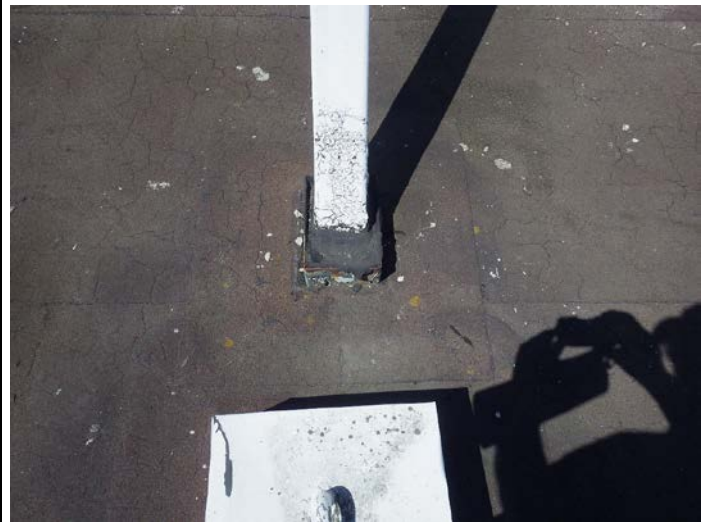
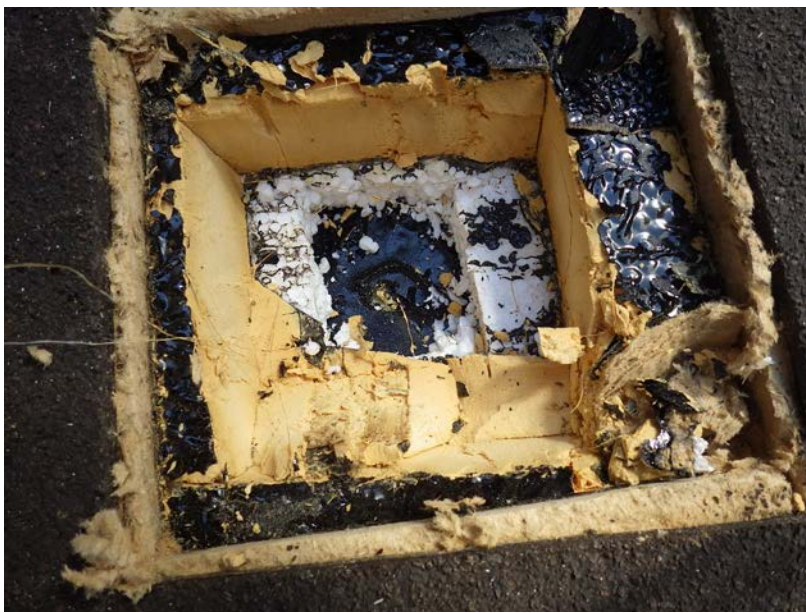
OPENING #02

Opening Type:	Membrane cut test.
Date of Opening:	July 15, 2014
Location:	Bldg "B" Southgate main roof
Observations:	Alligatoring, bare patches, failed penetration sealant.

Substrate Condition: Good

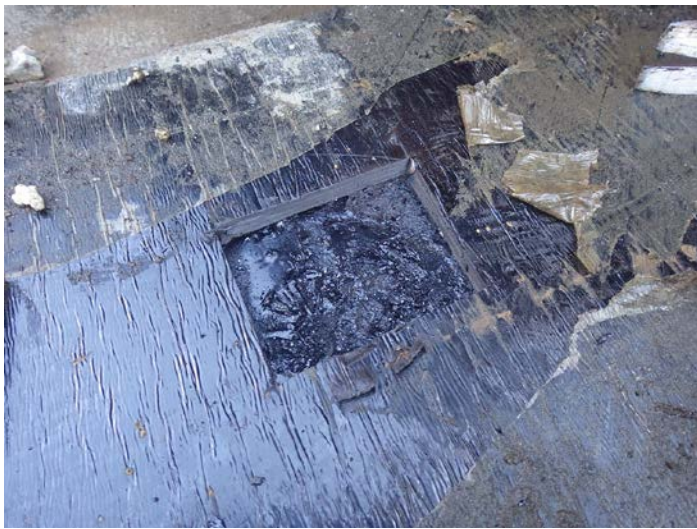
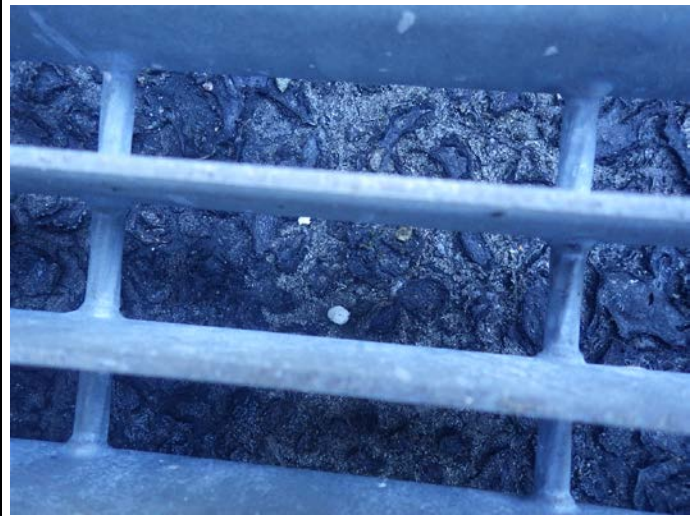
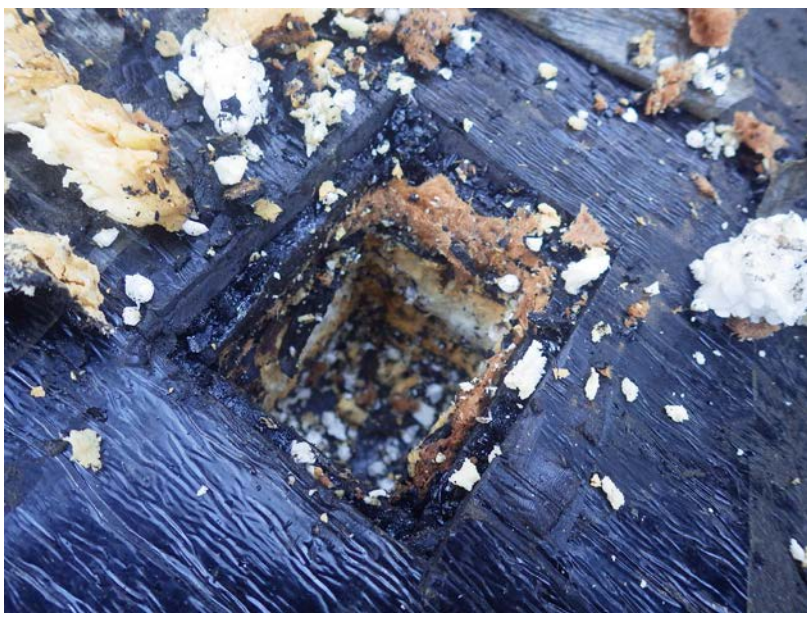
OPENING #03

Opening Type:	Membrane cut test
Date of Opening:	Sept. 12, 2014
Location:	Bldg "B" 804B
Observations:	Roof deck has pavers. Membrane looks almost new and still has thermo-fusible plastic film at the cut test location Cut reveals total saturation of the insulation plies. There appears to be some damage to the membrane in the drain location.

All layers of insulation are saturated with water.

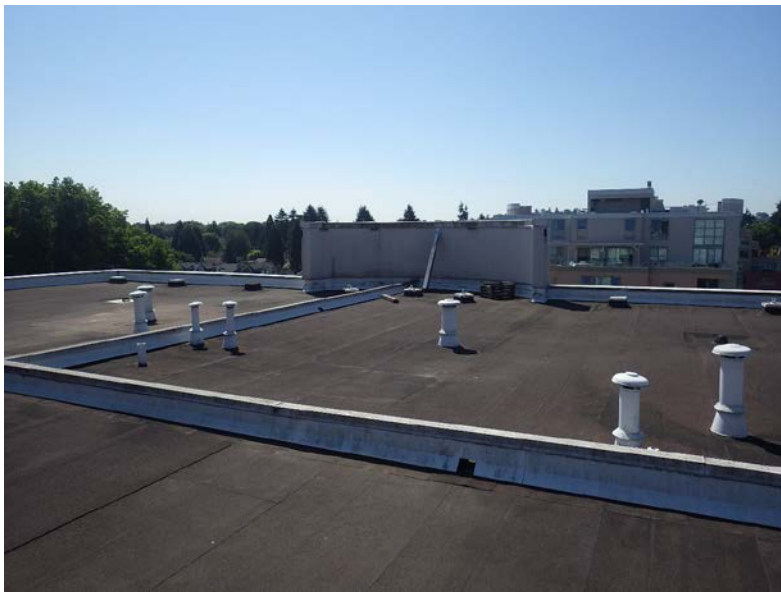
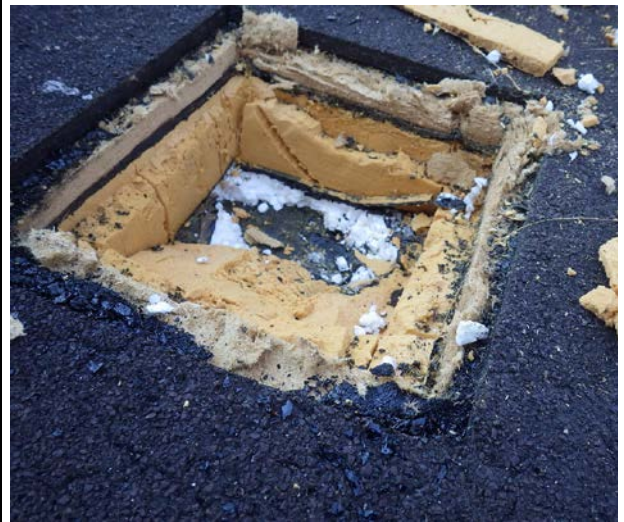
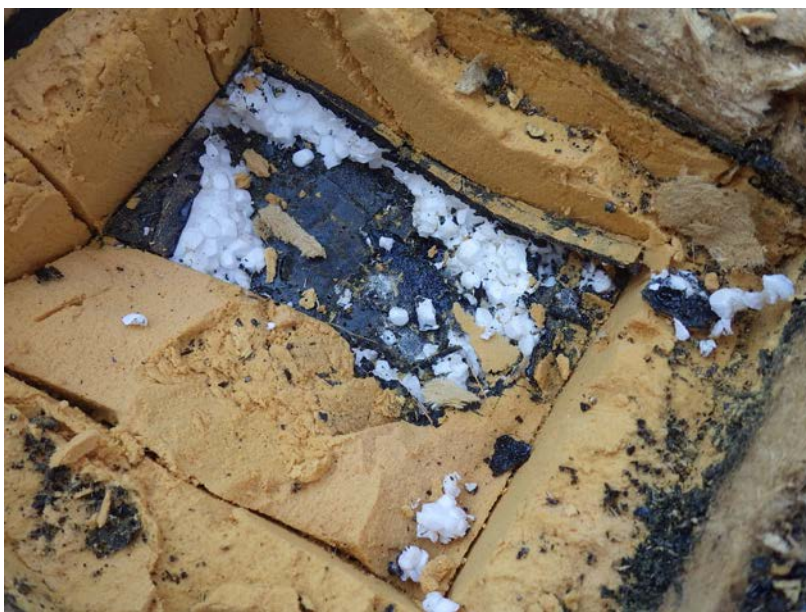
OPENING #04

Opening Type:	Membrane cut test
Date of Opening:	July 15, 2014
Location:	Bldg "C" Northgate NG main roof.
Observations:	Bare patches, exposed bitumen, alligatoring, a few repairs.
