Maintenance Review & Roofing Condition Assessment

Pacifica

Strata Plan LMS 597
503 West 16th Avenue
Vancouver, BC

Sept 29, 2014

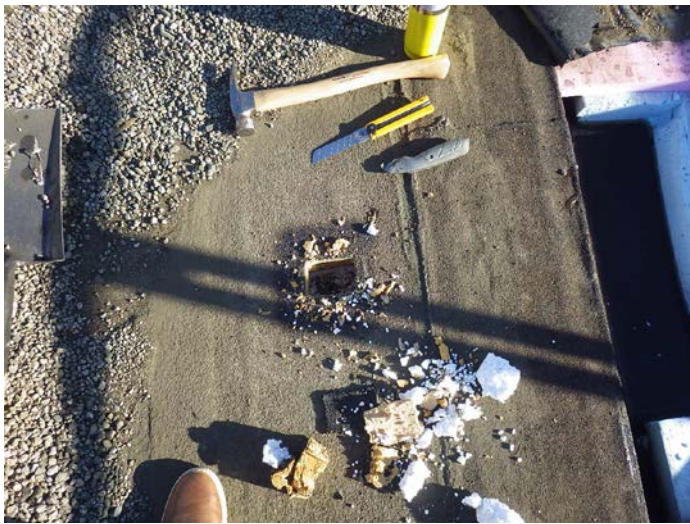
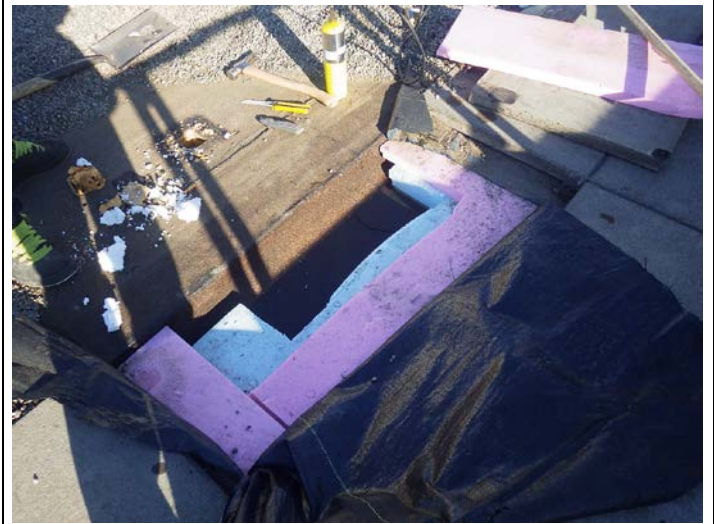
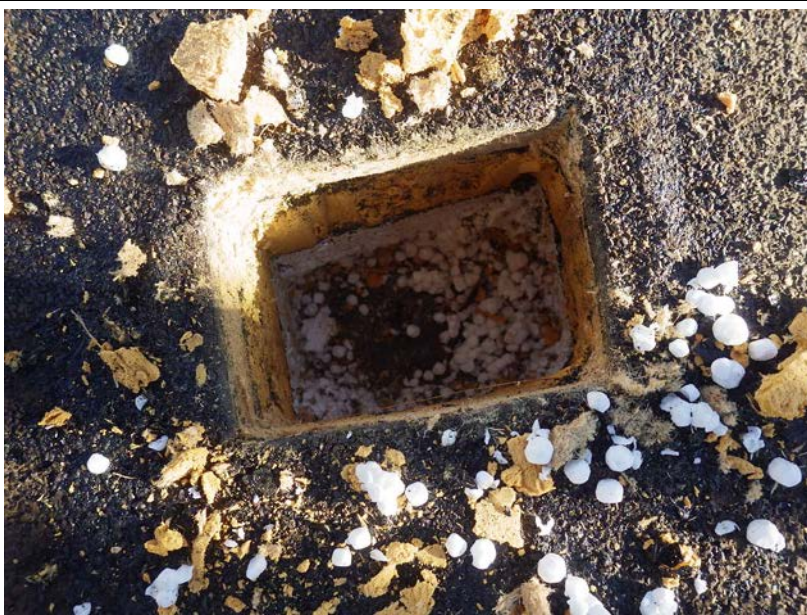
OPENING #05

Opening Type:	Membrane cut test
Date of Opening:	Sept. 12, 2014
Location:	Bldg "C" Northgate 801C
Observations:	Gravel is covering membrane and adjacent repair is a ballasted system which is holding water.

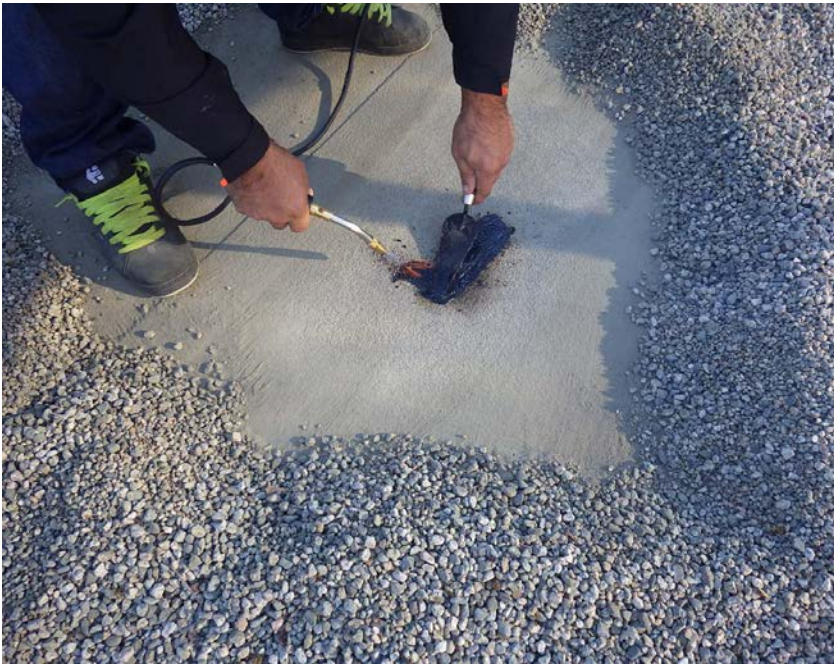
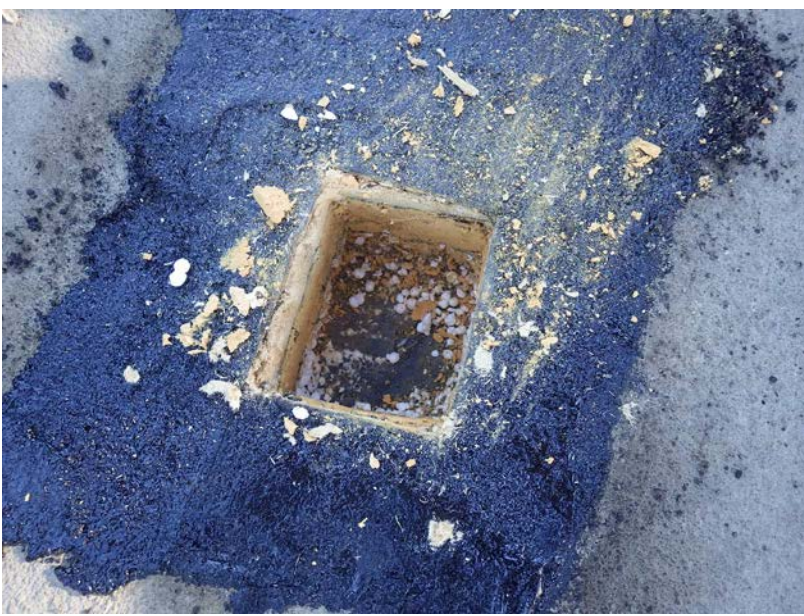
OPENING #06

Opening Type:	Membrane cut test.
Date of Opening:	Sept. 12, 2014
Location:	Bldg "C" Northgate 803C
Observations:	Parts of the deck are covered with gravel and board walkway. Some areas have pavers. There are many open laps, failed seams and stripping plies on this deck.

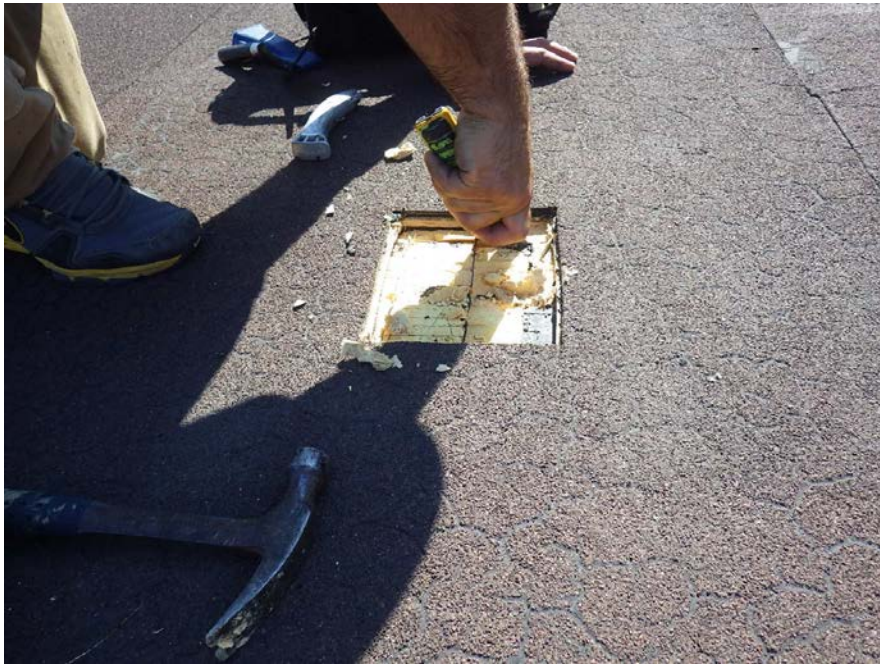
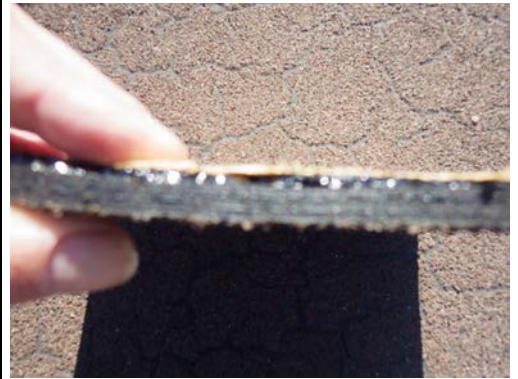
OPENING #07

Opening Type:	Membrane cut test
Date of Opening:	July 15, 2014
Location:	Bldg "D" Promenade Mews
Observations:	Many patches, Alligatoring, a few blisters. There is no vapour barrier in the assembly.

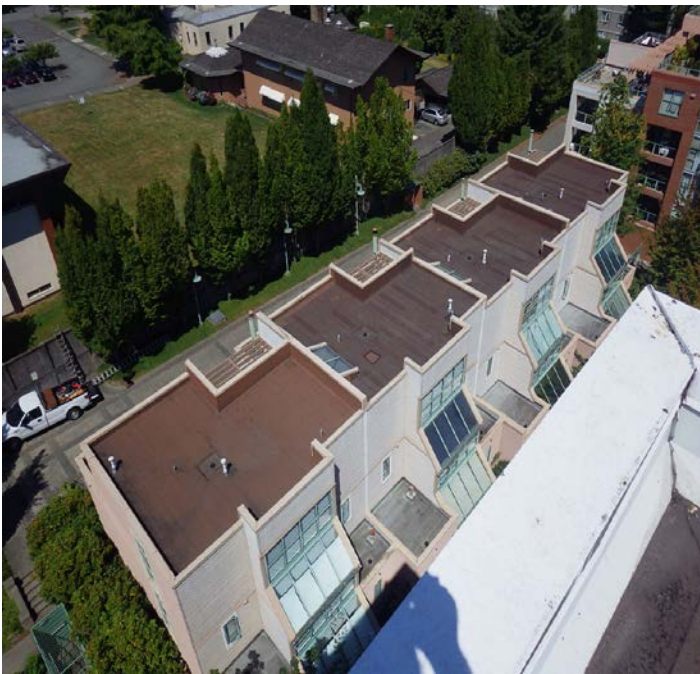
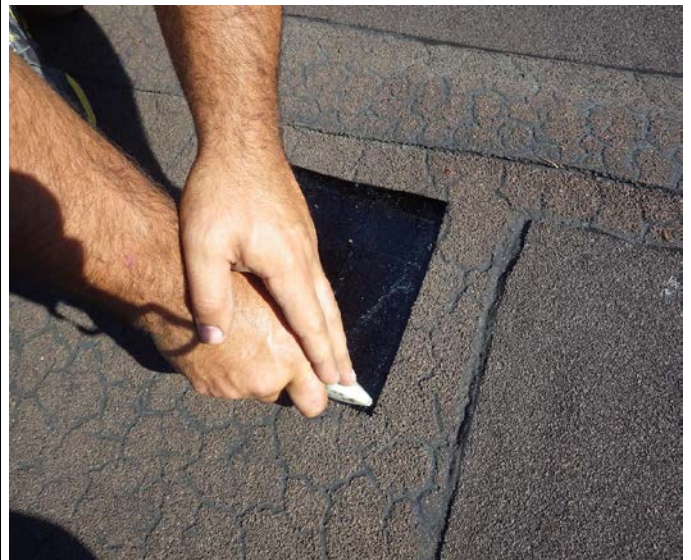
OPENING #08

Opening Type:	Membrane cut test
Date of Opening:	July 15,
Location:	Building "E" Promenade Mews
Observations:	There are some blisters, alligating and many patches. There is no vapour barrier in the assembly.

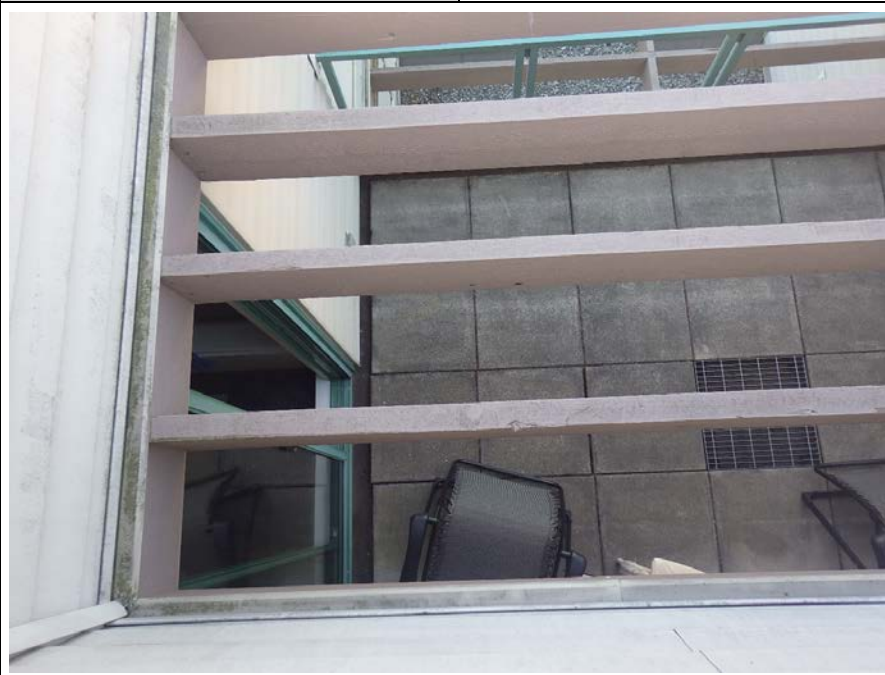
OPENING #09

Opening Type:	Membrane and substrate cut test
Date of Opening:	Sept. 12, 2014
Location:	Deck of 3150 (west side)
Observations:	No insulation or vapour barrier

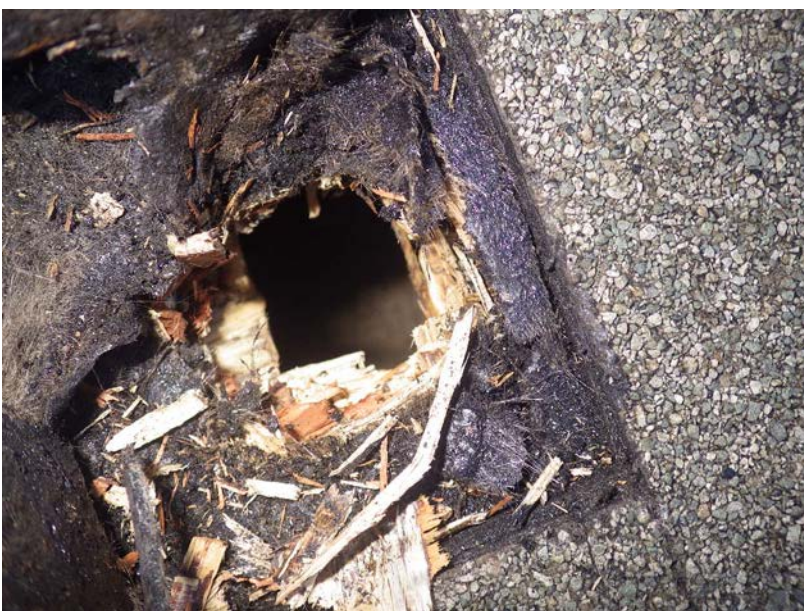
Close-Up View of Opening #10:

Opening Type:	Membrane and substrate cut test
Date of Opening:	Sept. 12, 2014
Location:	Lower roof 3150 (east side)
Observations:	There is no insulation or vapour barrier in the assembly.

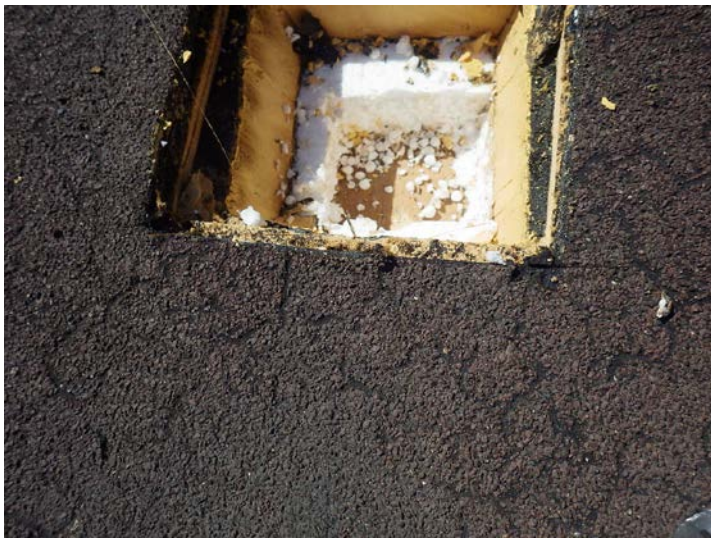
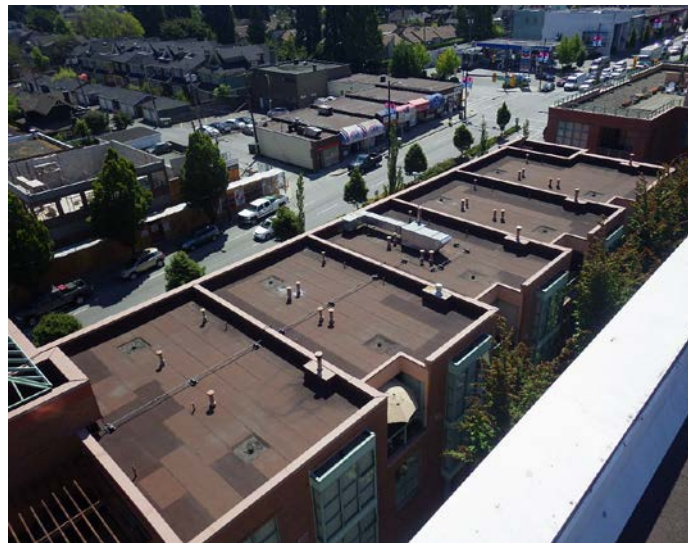
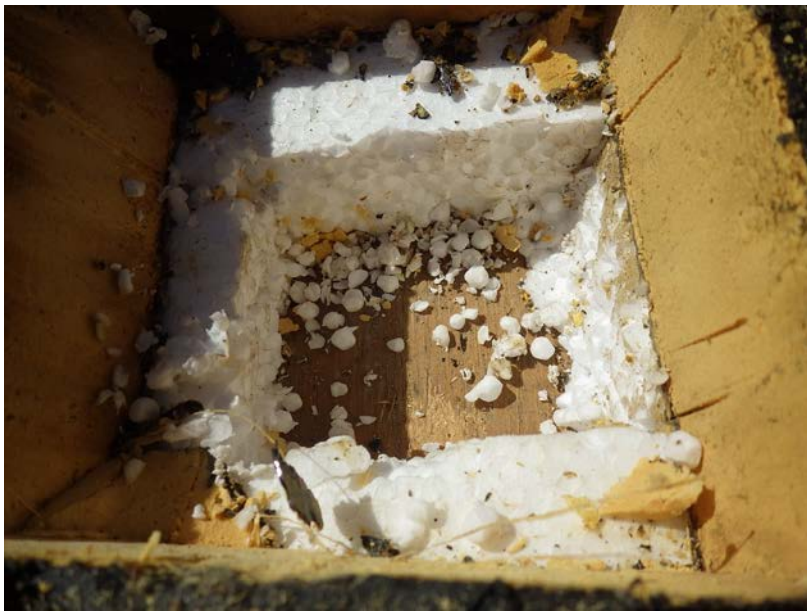
OPENING #11

Opening Type:	Membrane cut test
Date of Opening:	July 15, 2014
Location:	Bldg "F" Cityhomes
Observations:	Membrane has been overlaid with additional membrane during warranty claim. There is alligatoring of the cap sheet, and a few blisters.

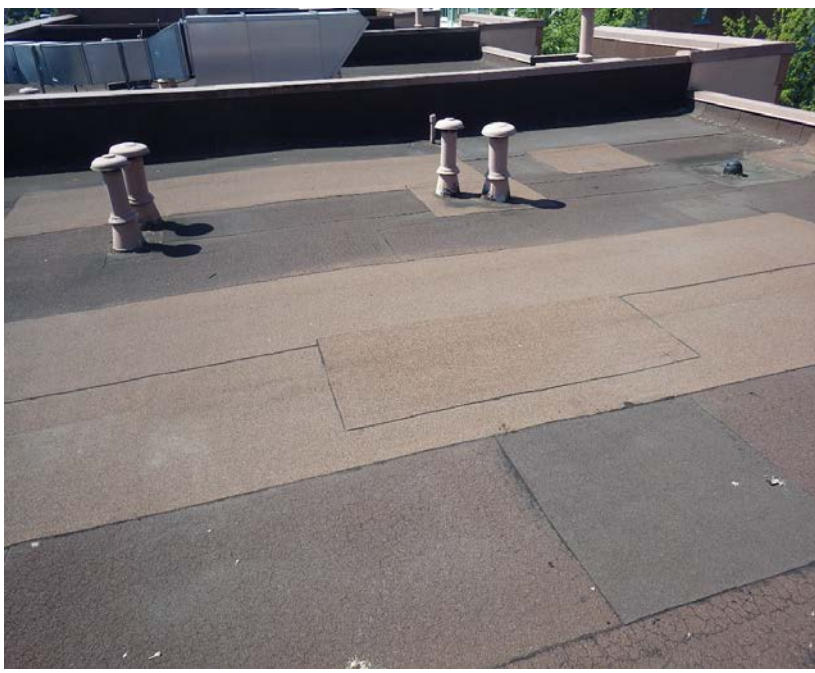
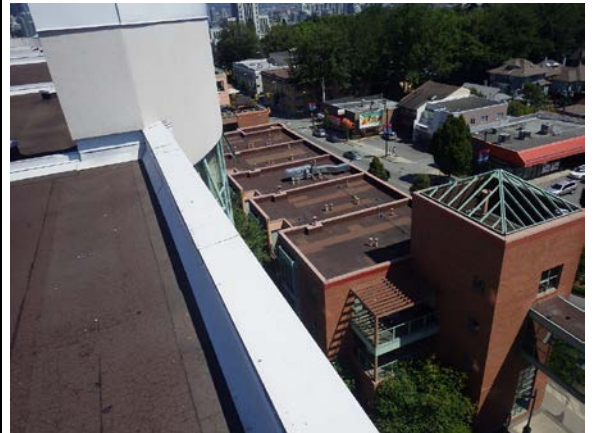
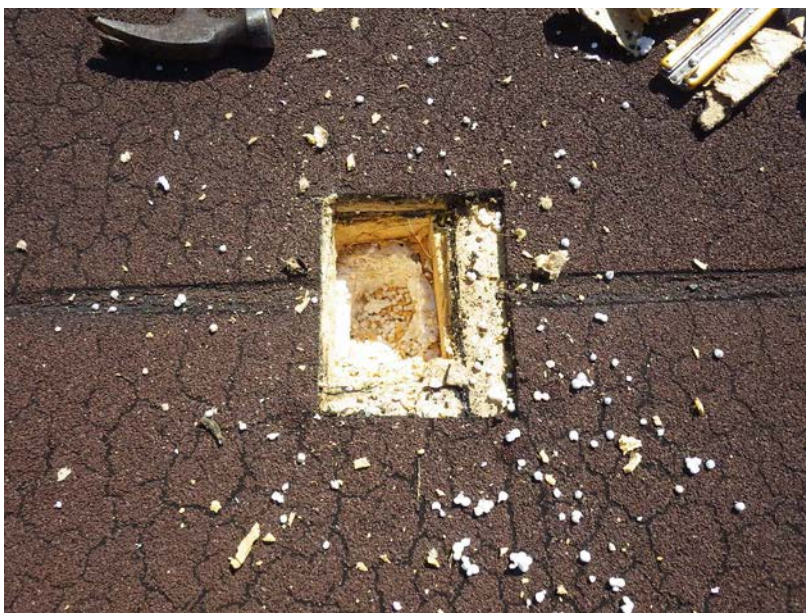
OPENING #12

Opening Type:	Membrane cut test
Date of Opening:	July 15, 2014
Location:	Bldg "G" Cityhomes
Observations:	Alligatoring, repair patches, some blisters.
