Maintenance Review & Roofing Condition Assessment

Pacifica

Strata Plan LMS 597
503 West 16th Avenue
Vancouver, BC

Sept 29, 2014

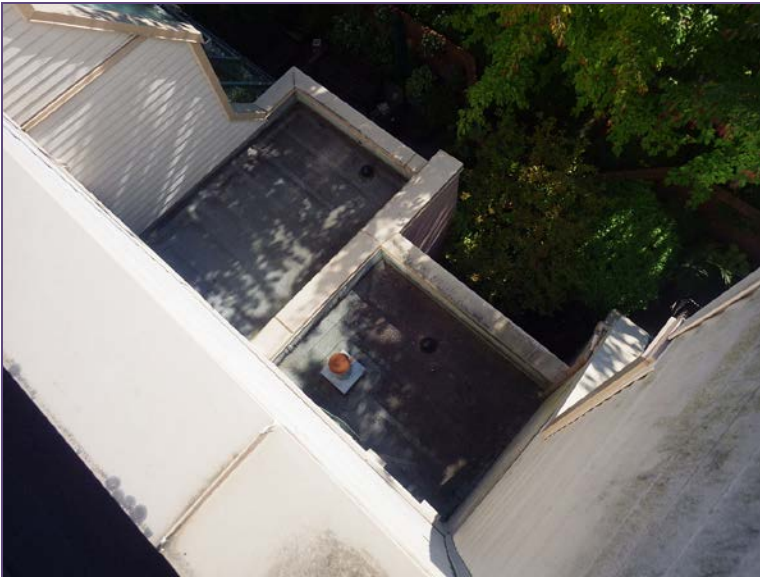
3. Promenade Mews: Leaf screens are performing their intended function. Drain clearing should coincide with gutter cleaning, and be performed once per year minimum.

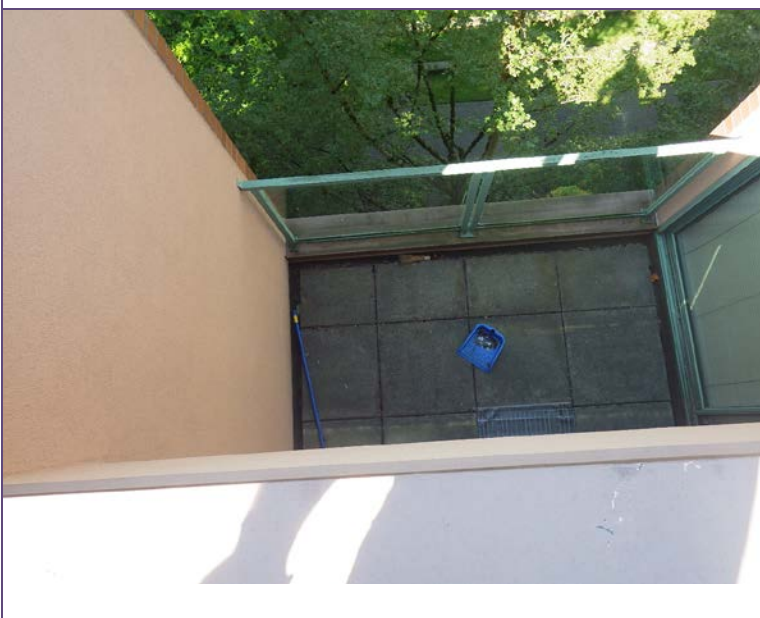
20. Bldg. “E” Cityhomes: A view down onto a typical balcony deck reveals heavy dirt and organic debris buildup on paver surface. Trellises at this building will require paint touchups and repair.

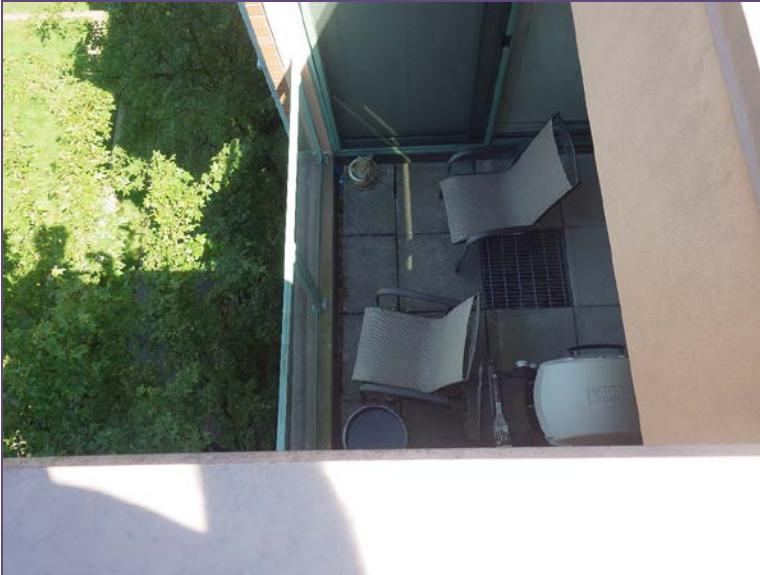
21. Bldg “E” Cityhomes: This particular balcony is clean.

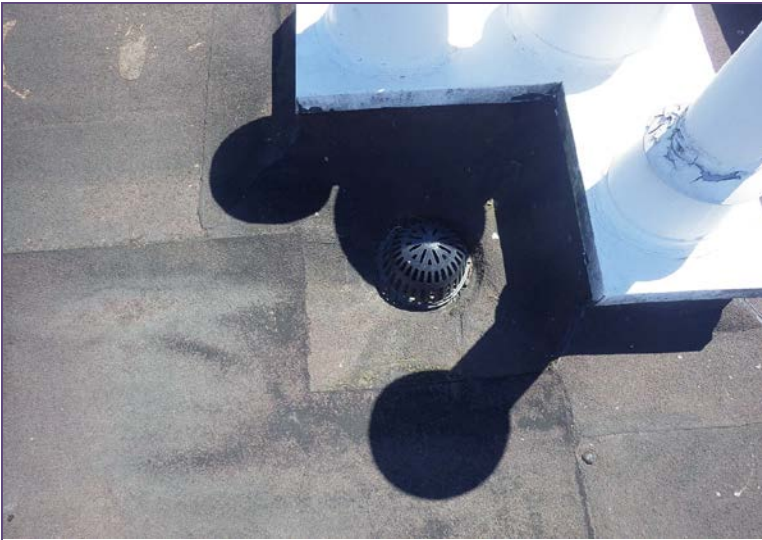
Alligating (visible cracking pattern) of the cap sheet, blisters, loose seams and de-bonded stripping plies were evident throughout all the main roofs and only the extent of the aging is different. Many patches and repair seams are evident throughout buildings “D” & “E” (Promenade Mews) and “F” & “G” (Cityhomes) which are both wood frame buildings both of which do not have a vapour retarder in the assembly. Of the three main buildings “A” (Maingate), “B” (Southgate) & “C” (Northgate) it is building “C” that is showing the most age related deterioration [24].

24. Bldg “C” Northgate: There are many bare spots.

Based upon our observations, membrane cut tests and historical records, it is our opinion that the main roofs of all buildings will at least meet their expected service life of 25 years and that immediate replacement of exposed membrane on main roofs (except for Promenade Mews) is not necessary at this time. Main roof membrane replacement at all buildings except Promenade Mews may be deferred by 3 to 5 years. Roof membrane replacement should be considered deferred but imminent, and budget forecasting should account for staged replacement beginning in 2018. On a priority ranking system Bldg. "C" Northgate main roof should be replaced in 2018.

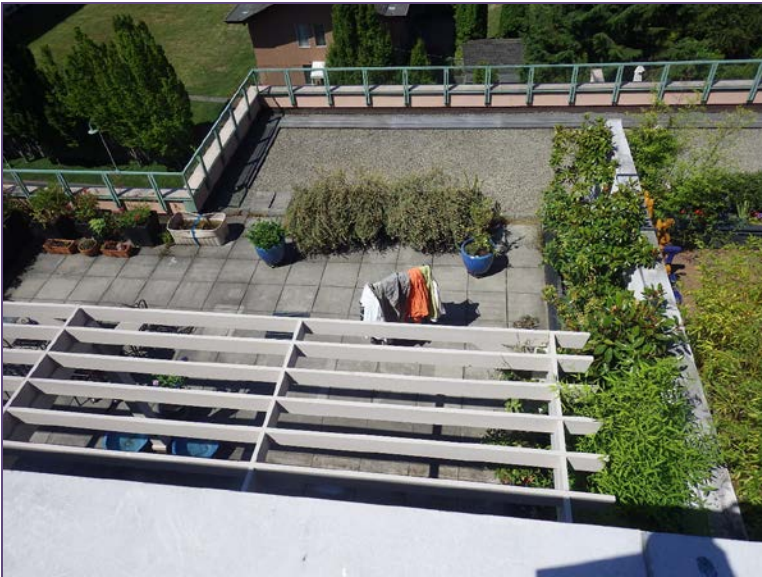
30. Bldg. “C” 8th floor roof decks. Trellis, railings pavers is in good condition. Roof decks are generally tidy and well kept. Membrane at the perimeter of these decks is in marginal condition.

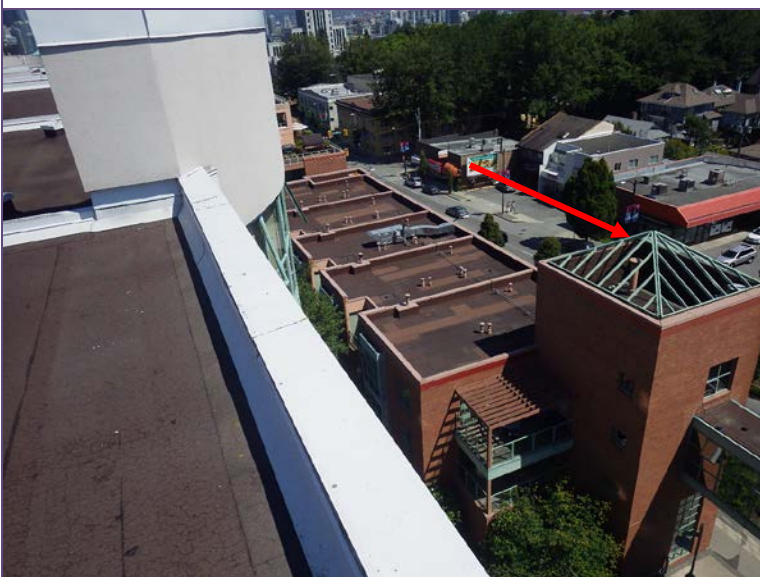
35. Bldg “F” Cityhomes: Looking down on main roof. Different shades of cap sheet indicate areas where the roof had additional plies of membrane installed under a warranty claim.

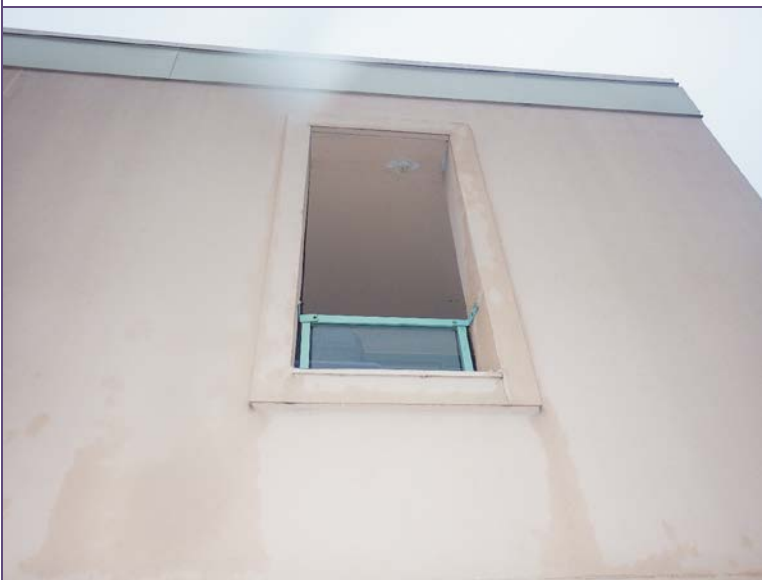
It is evident from historical records that there are some consistently problematic details with respect to membrane interface at roof deck membrane & wall base. Leaks typically occur at door openings and curbs adjacent to EIFS clad walls. The leaks can usually be attributed to wall details and not necessarily roof membrane failure. During the original construction EPS insulation was installed vertically against the concrete curb of the exterior wall with roofing membrane upturned onto the exterior side of the insulation. A flashing was installed above the upturn but it is not installed in a manner that directs water out if water were to enter the wall assembly at a higher point. Sealant failure at joints, penetrations and windows within EIFS allows water to bypass the waterproofing membrane by running down the sheathing behind the insulation and manifest itself as a leak into a unit. Historical records indicate these conditions which can be represented by photographs [47, 50].

47. Another view with wall base membrane removed.

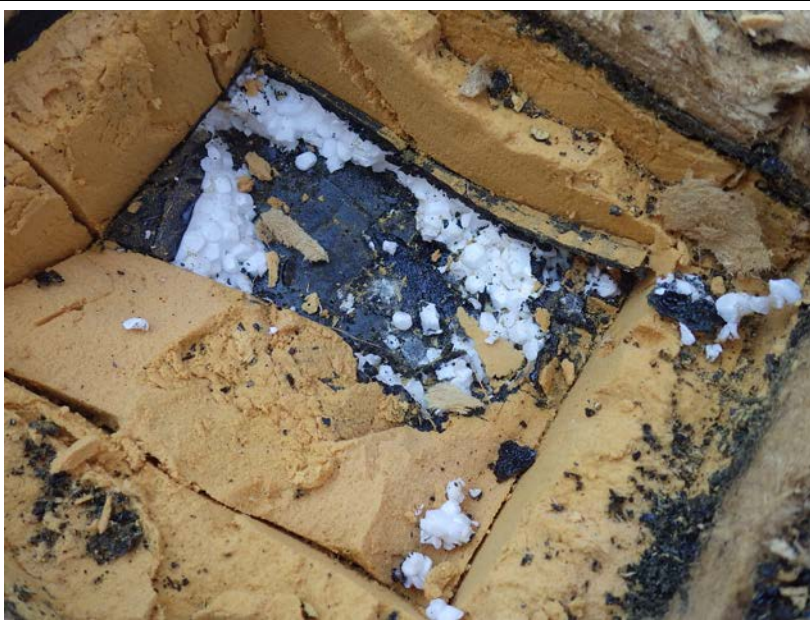
Close-Up View of Opening #01:

Opening Type:	Membrane cut test
Date of Opening:	July 15, 2014
Location:	Bldg "A" Maingate main roof
Observations:	Alligatoring, bare spots, and many patches on the roof surface.

2 ply SBS
 2 layers ½" fibreboard (mopped)
 2" phenolic Resin Insulation(mopped)
 ½" EPS insulation (taperslope varies)
 Asphalt Flood coat on concrete deck

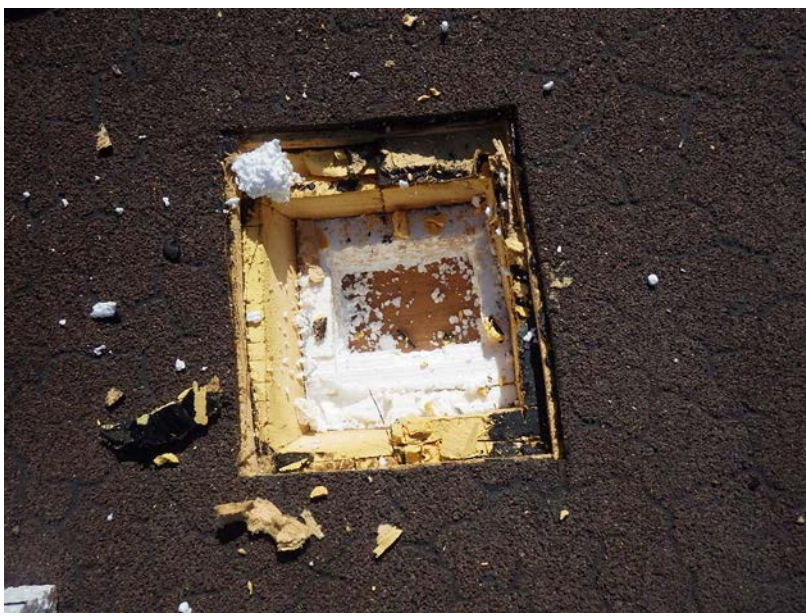
Close-Up View of Opening #07:

Opening Type:	Membrane cut test
Date of Opening:	July 15, 2014
Location:	Bldg "D" Promenade Mews
Observations:	Many patches, Alligatoring, a few blisters. There is no vapour barrier in the assembly.

2ply SBS membrane
 ½" fibreboard (mopped)
 2" Phenolic Resin Insulation
 1" EPS Foam (taper slope varies in thickness)
 Plywood deck

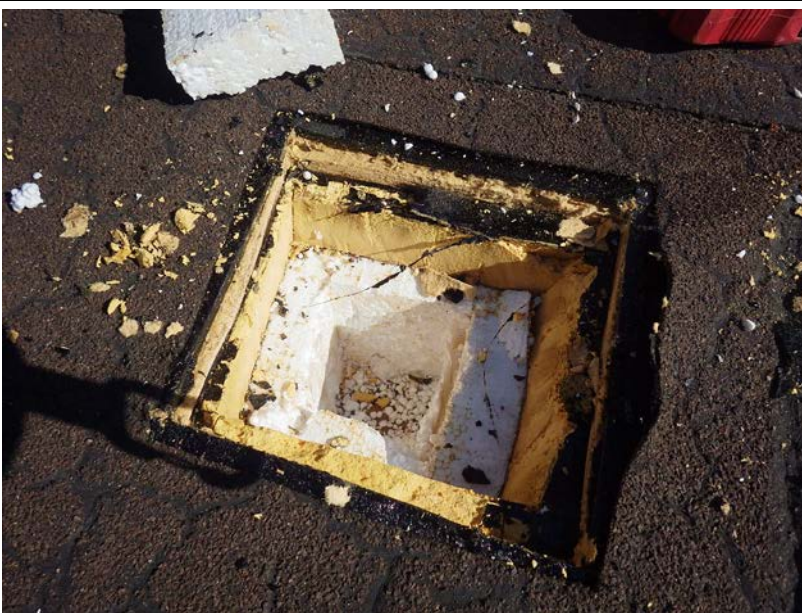
Close-Up View of Opening #08:

Opening Type:	Membrane cut test
Date of Opening:	July 15,
Location:	Building "E" Promenade Mews
Observations:	There are some blisters, alligating and many patches. There is no vapour barrier in the assembly.

2ply SBS membrane
 ½" fibreboard (mopped)
 1-½" Phenolic Resin Insulation
 3" EPS Foam
 Plywood deck

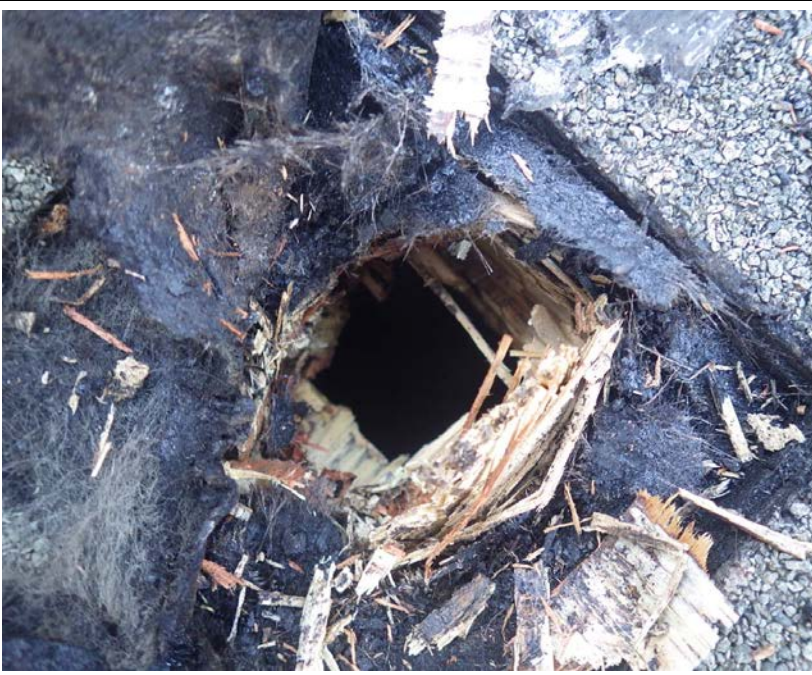
Close-Up View of Opening #09:

Opening Type:	Membrane and substrate cut test
Date of Opening:	Sept. 12, 2014
Location:	Deck of 3150 (west side)
Observations:	No insulation or vapour barrier

2 ply SBS membrane
Plywood over wood joists
Gypsum ceiling

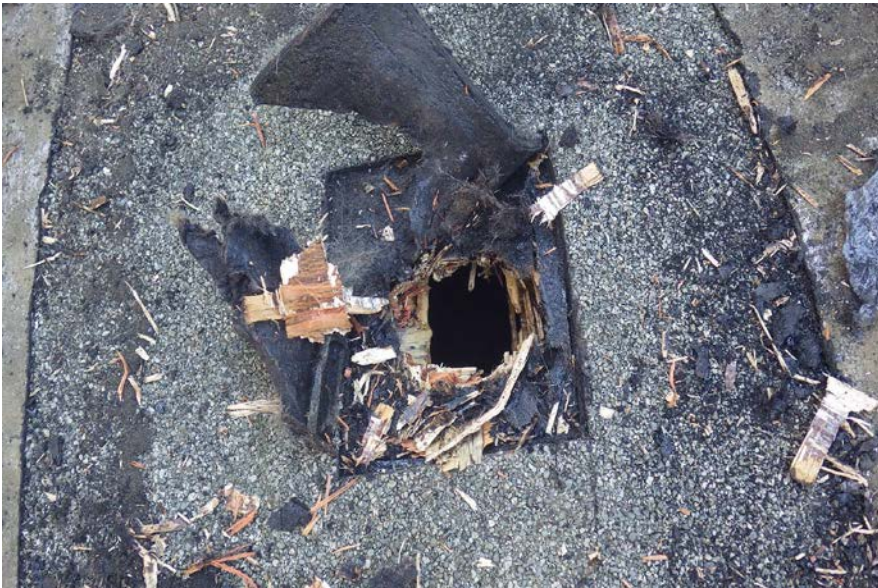
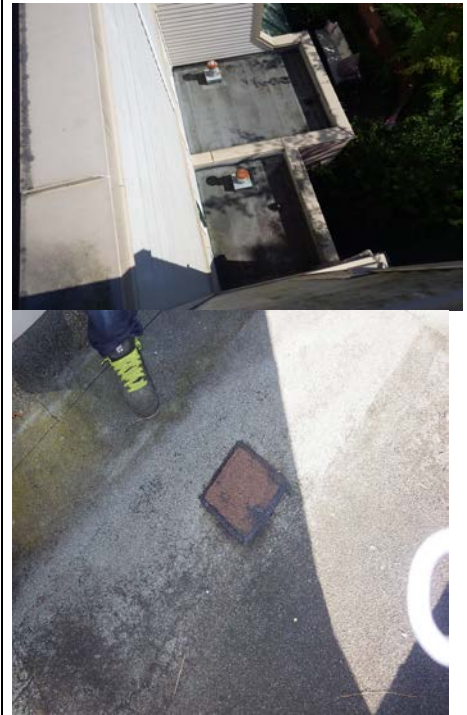
OPENING #10

Lower roof shown is similar to 3150

Opening Type:	Membrane and substrate cut test
Date of Opening:	Sept. 12, 2014
Location:	Lower roof 3150 (east side)
Observations:	There is no insulation or vapour barrier in the assembly.
